FULL-DEPTH REPAIR OF JOINTED PCC PAVEMENTS  
CAST-IN-PLACE AND PRECAST PROCEDURES

Samuel S. Tyson  
Research Engineer

Virginia Highway & Transportation Research Council  
(A Cooperative Organization Sponsored Jointly by the Virginia  
Department of Highways & Transportation and  
the University of Virginia)

March 1976  
VHTRC 76-R44

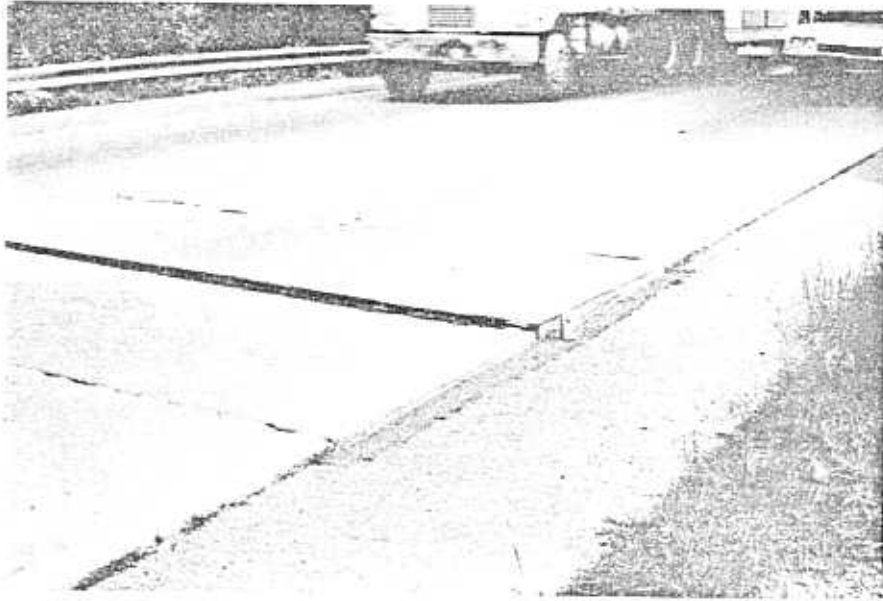
Figure 1. Faulting of repaired transverse joint due to pumping of subbase fines.

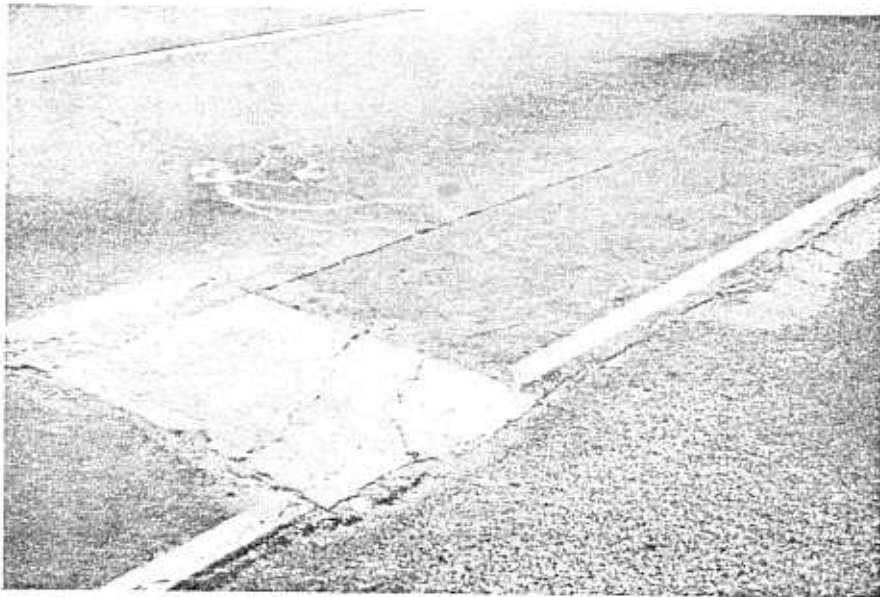
The enduring quality of some repairs installed by state crews is demonstrated in Figure 2. Repairs such as this, away from the transverse joints, are not typical. However, it is of interest to note that the light colored patch in the foreground, placed by a contract crew alongside the repair placed 2 years earlier by a state crew, failed at an age of 1 month. Aside from the fact that the second patch was not adequately consolidated, the problem with the initial repair was that it did not extend far enough to remove all of the unsound concrete.

Figure 2. Initial full-depth repair in background did not remove all unsound concrete. Subsequent repair in foreground did not receive adequate consolidation.

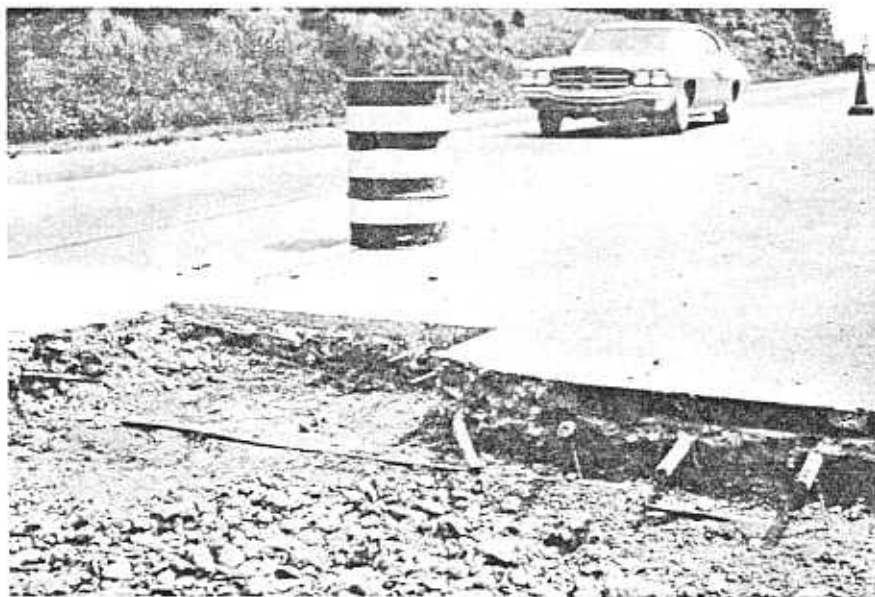
Various other situations can lead to difficulty with full-depth repairs. In Figure 3 several of the dowels at the transverse joint have been removed with the unsound concrete. The risk with this incomplete restoration is that all of the dowels may not be properly aligned when the repair concrete is cast and the transverse joint may be prevented from functioning properly.

Figure 3. Incomplete full-depth restoration presents difficulty with dowel alignment.

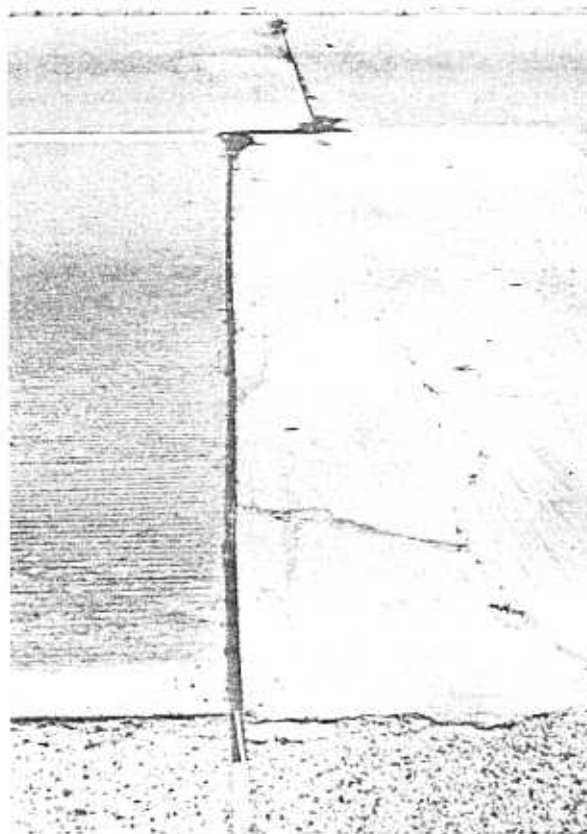
In Figure 4 the undoweled replacement joint in the near lane is not functioning. Since the lanes are in contact at the centerline and some bond strength must have developed along the lower face of the replacement joint, contraction has been accommodated in the repair concrete by a crack that formed in general alignment with the working joint in the far lane. The intended working joint should have been restored at the location of the original transverse joint.

Figure 4. Full-depth replacement joint not functioning due to misalignment.

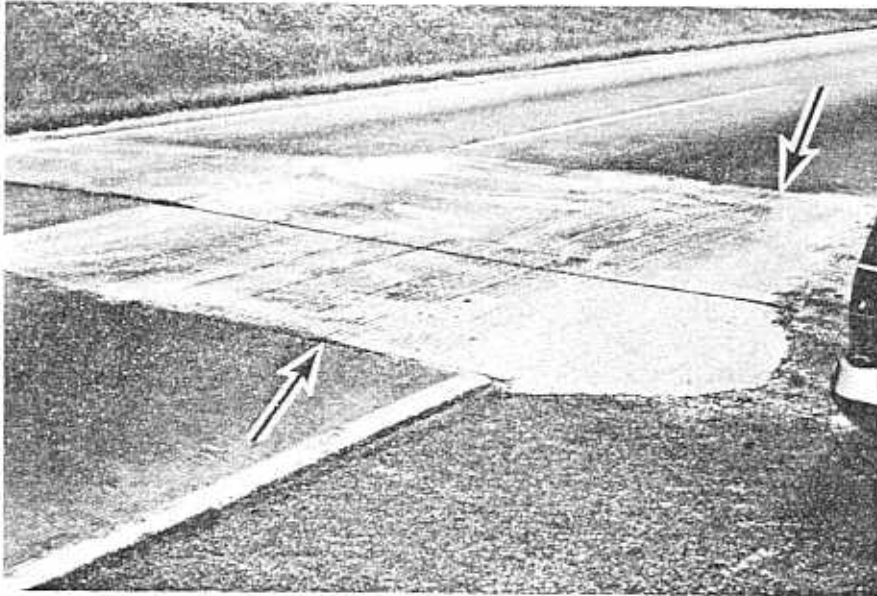
Even though care was exercised to restore the doweled joint in Figure 5, transverse cracks formed at the repair limits. Shoulder material had been removed with the deteriorated concrete pavement so that casting of the repair concrete beyond the edge limit of the existing slab caused the repair to be keyed into the shoulder. The repair tended to remain stationary with the shoulder as the old pavement contracted longitudinally and pulled away.

Figure 5. Full-depth restoration keyed into shoulder resulted in transverse cracks indicated by arrows.

5. Repairs should be carefully formed at the shoulders to avoid abnormal restraint of slab movements.
6. Restored transverse joints must be aligned with transverse joints in adjacent lanes in order to function properly. If dowel assemblies are used for load transfer, the dowels must be accurately positioned.

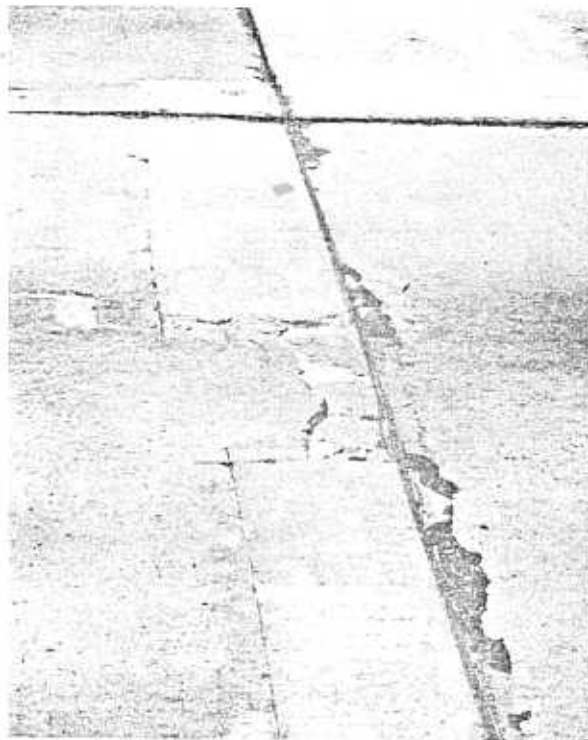
Due to the several combinations of factors that may cause deterioration<sup>(1)</sup> some difficulty has been experienced in determining the severity of distress that has existed in some pavement locations that have been repaired. After the transverse joint in the near lane in Figure 6 received partial-depth repairs the far lane underwent full-depth restoration. Within a week of the full-depth repair, spalling was observed in the near lane. Full-depth removal of the concrete in the far lane relieved the compressive stresses that had not already been relieved in that lane through extensive deterioration of the concrete. Because the two lanes were connected by tie bars at the pavement centerline, the transverse joint of the near lane carried an increased compressive stress. This stress level and resultant strain was apparently sufficient to cause the additional spalling.

Figure 6. Continued deterioration of concrete in foreground occurred after full-depth restoration of lane in background.

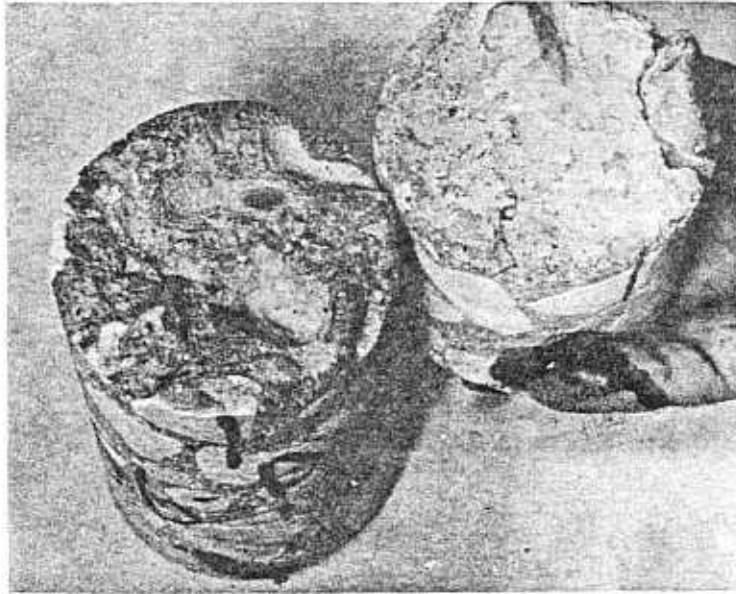
Unsound concrete was found in the area in the near lane to the left of the second partial-depth patch by hammer soundings. The core shown in Figure 7 was removed from the old pavement approximately two feet from the transverse joint. A nearly horizontal fracture plane was found at a depth of 5 inches (127 mm). This was not surprising because of the increased joint stresses. However, examination through X-ray diffraction techniques of material in the fracture plane revealed not only finely ground compacted concrete that was very unlikely to have been deposited during the wet drilling, but also an underlying thin coherent layer of calcite. This finding suggested that the fracture had existed prior to the time that the repairs were made at either joint since the calcite, formed by a reaction between  $\text{Ca(OH)}_2$  in the concrete and  $\text{CO}_2$  from the atmosphere, in the amount observed would have required a longer period of time to form than the 90-day period that elapsed between the initial repair installation and the coring operation. Identification of pavement distress by visual means only is obviously not sufficient.

Figure 7. Fracture plane in old pavement containing compacted layer of finely ground concrete underlain by thin coherent layer of calcite.

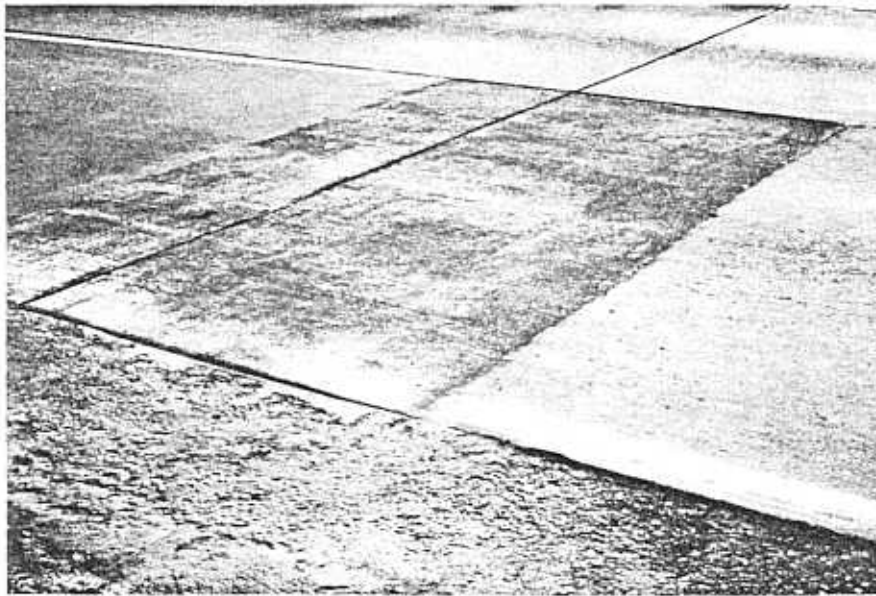
Thirteen initial repairs of the type shown in Figure 11 have performed satisfactorily for more than 2 years. The functioning of the restored transverse joints and the proper tie-in at the construction joints between the repair concrete and existing pavement slabs were studied. Movements in several of the restored

Figure 11. Hardened cast-in-place restoration made with HAC concrete.

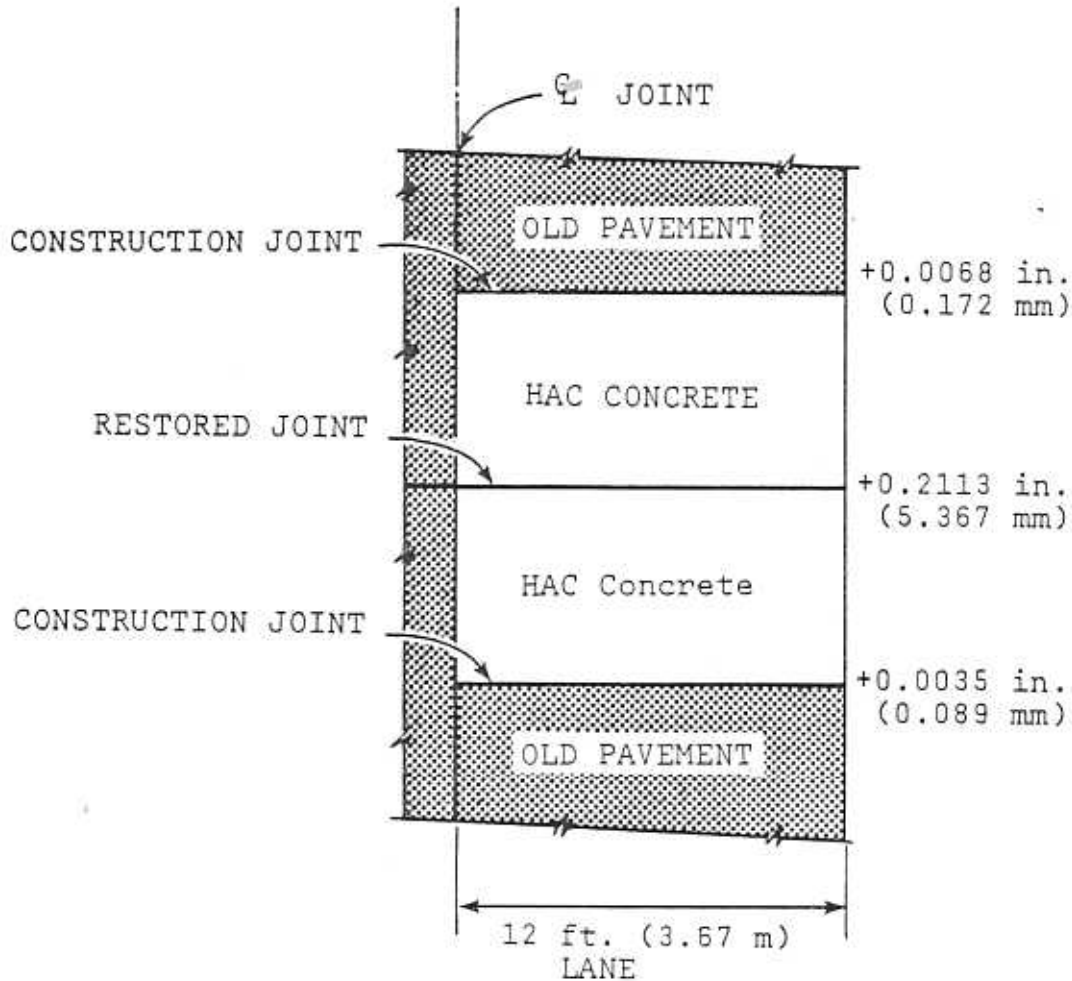
Figure 12 shows typical data recorded during the joint monitoring. The ratio of the restored joint movement to the average of the two construction joint movements was 40 to 1, which shows that practically all of the slab movements were being accommodated by the transverse contraction joint. This was the desired behavior. The observed movement for the working joint was 0.2113 inch (5.367 mm), which compared quite well with the predicted value of 0.1800 inch (4.572 mm). The tightness of the construction joints can be attributed to the careful tie-in of reinforcement mesh between the old pavement and the repair concrete. The vertical section of a core drilled down through the construction joint reveals the overlapped transverse bars of the mesh in Figure 13. Excellent potential for load transfer can be seen in the mechanical interlock between concretes in that figure. The favorable irregular face in the old pavement was created by the concrete removal technique described earlier, and good bonding was achieved at the construction joint interface by adequate consolidation following the application of a bonding slurry made of HAC.

Figure 12. Joint movements (+ openings) occurring over a 17-hour period with an ambient temperature change from 75° F to 28° F (24° C to -2° C).

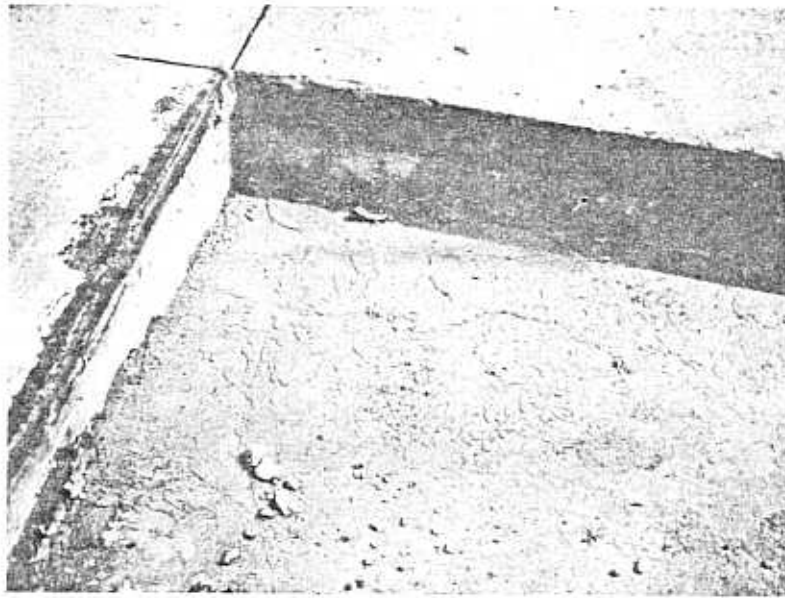
Figure 31. Fine subbase material infiltrated between mortar layer and precast slab from underneath adjacent roadway areas (roadway centerline on left).
