I-66 Highways for LIFE

PCI PAVEMENT COMMITTEE

Karen L. Consiglio, P.E.

September 10, 2009

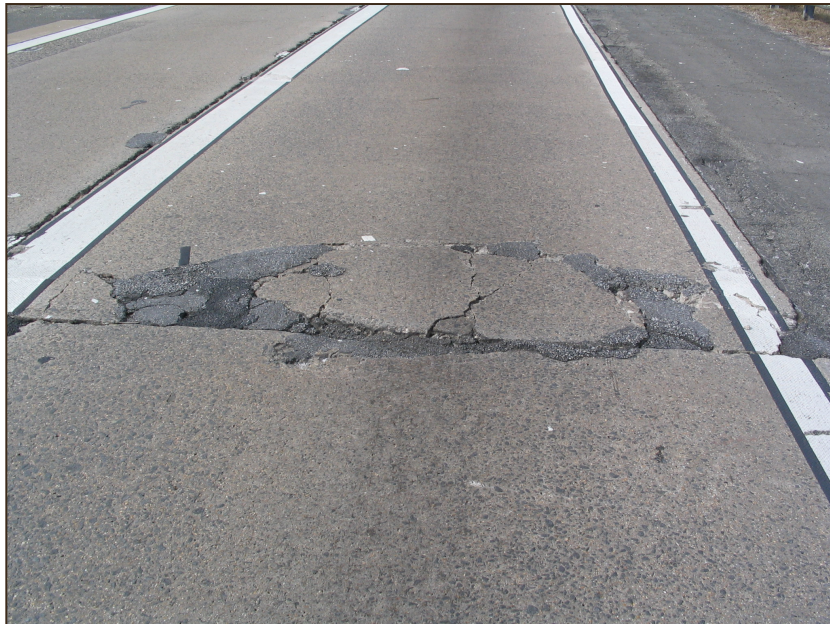
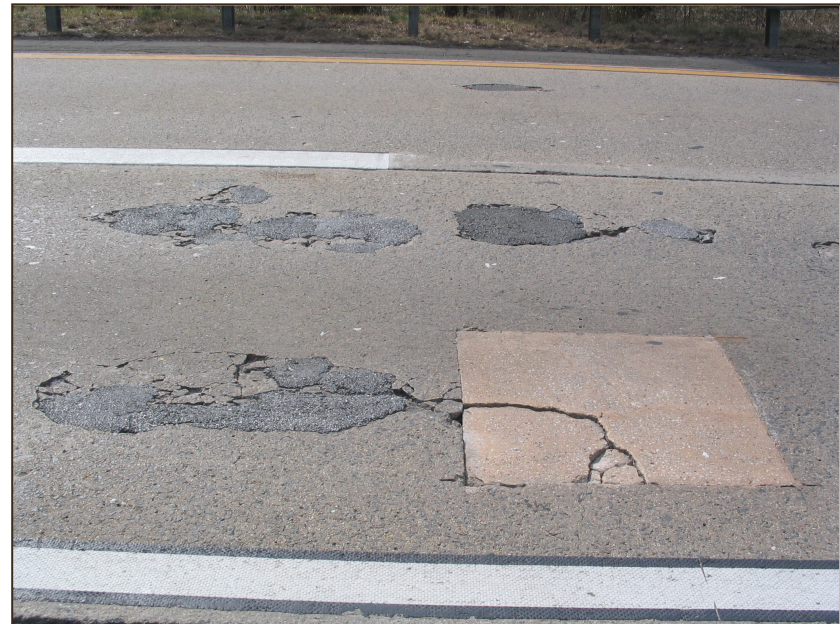
- 9" JRCP built in early 1960s
- 6" of plain aggregate sub-base
- 6" cement stabilized sub-grade
- Lot of joint problems and mid-slab spalling

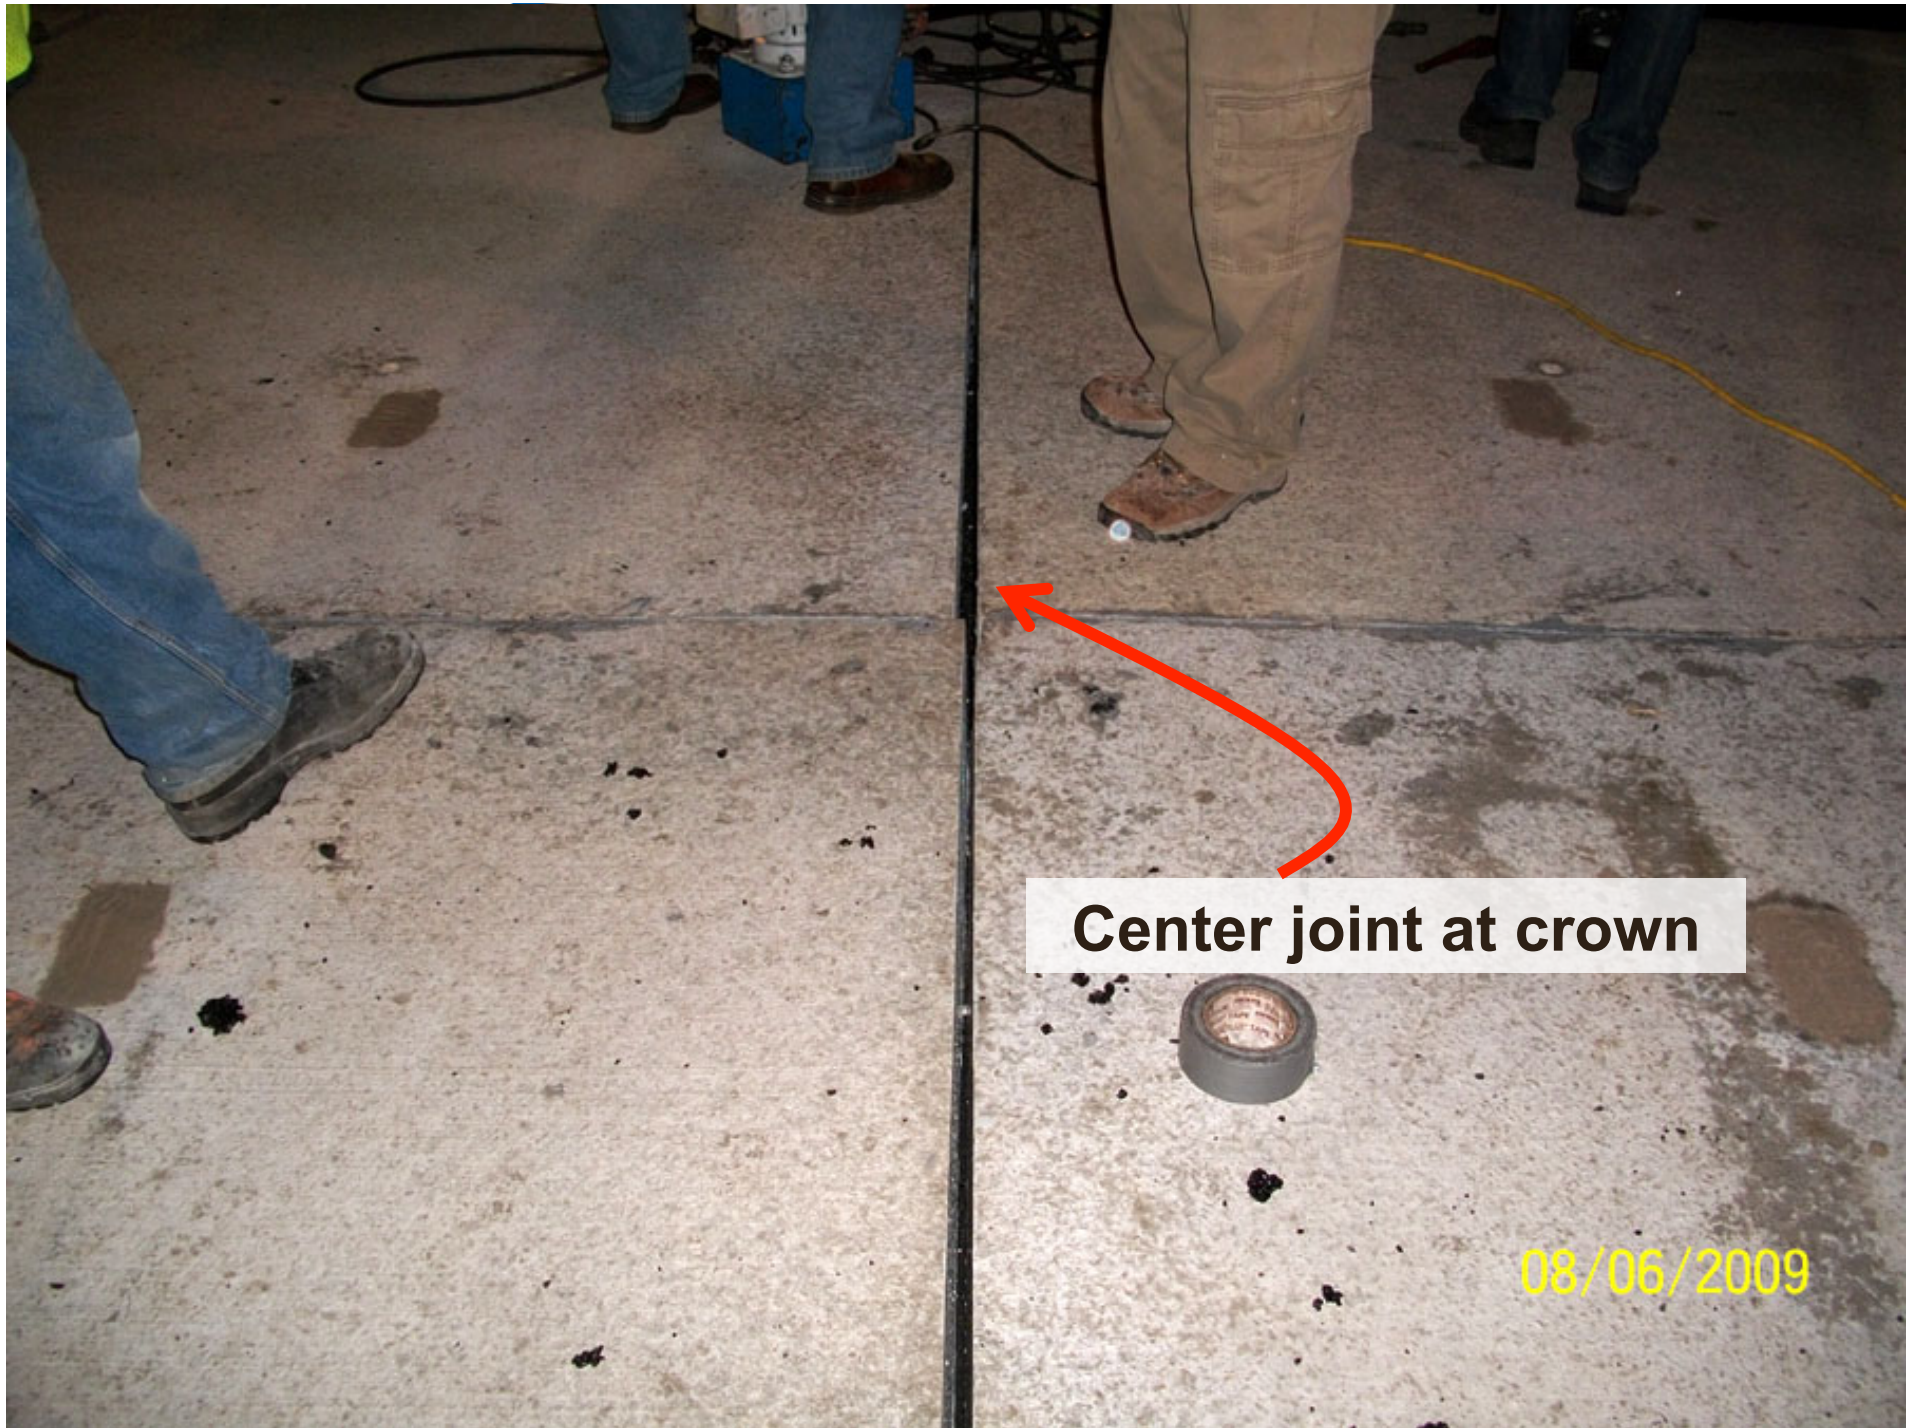
Center joint at crown

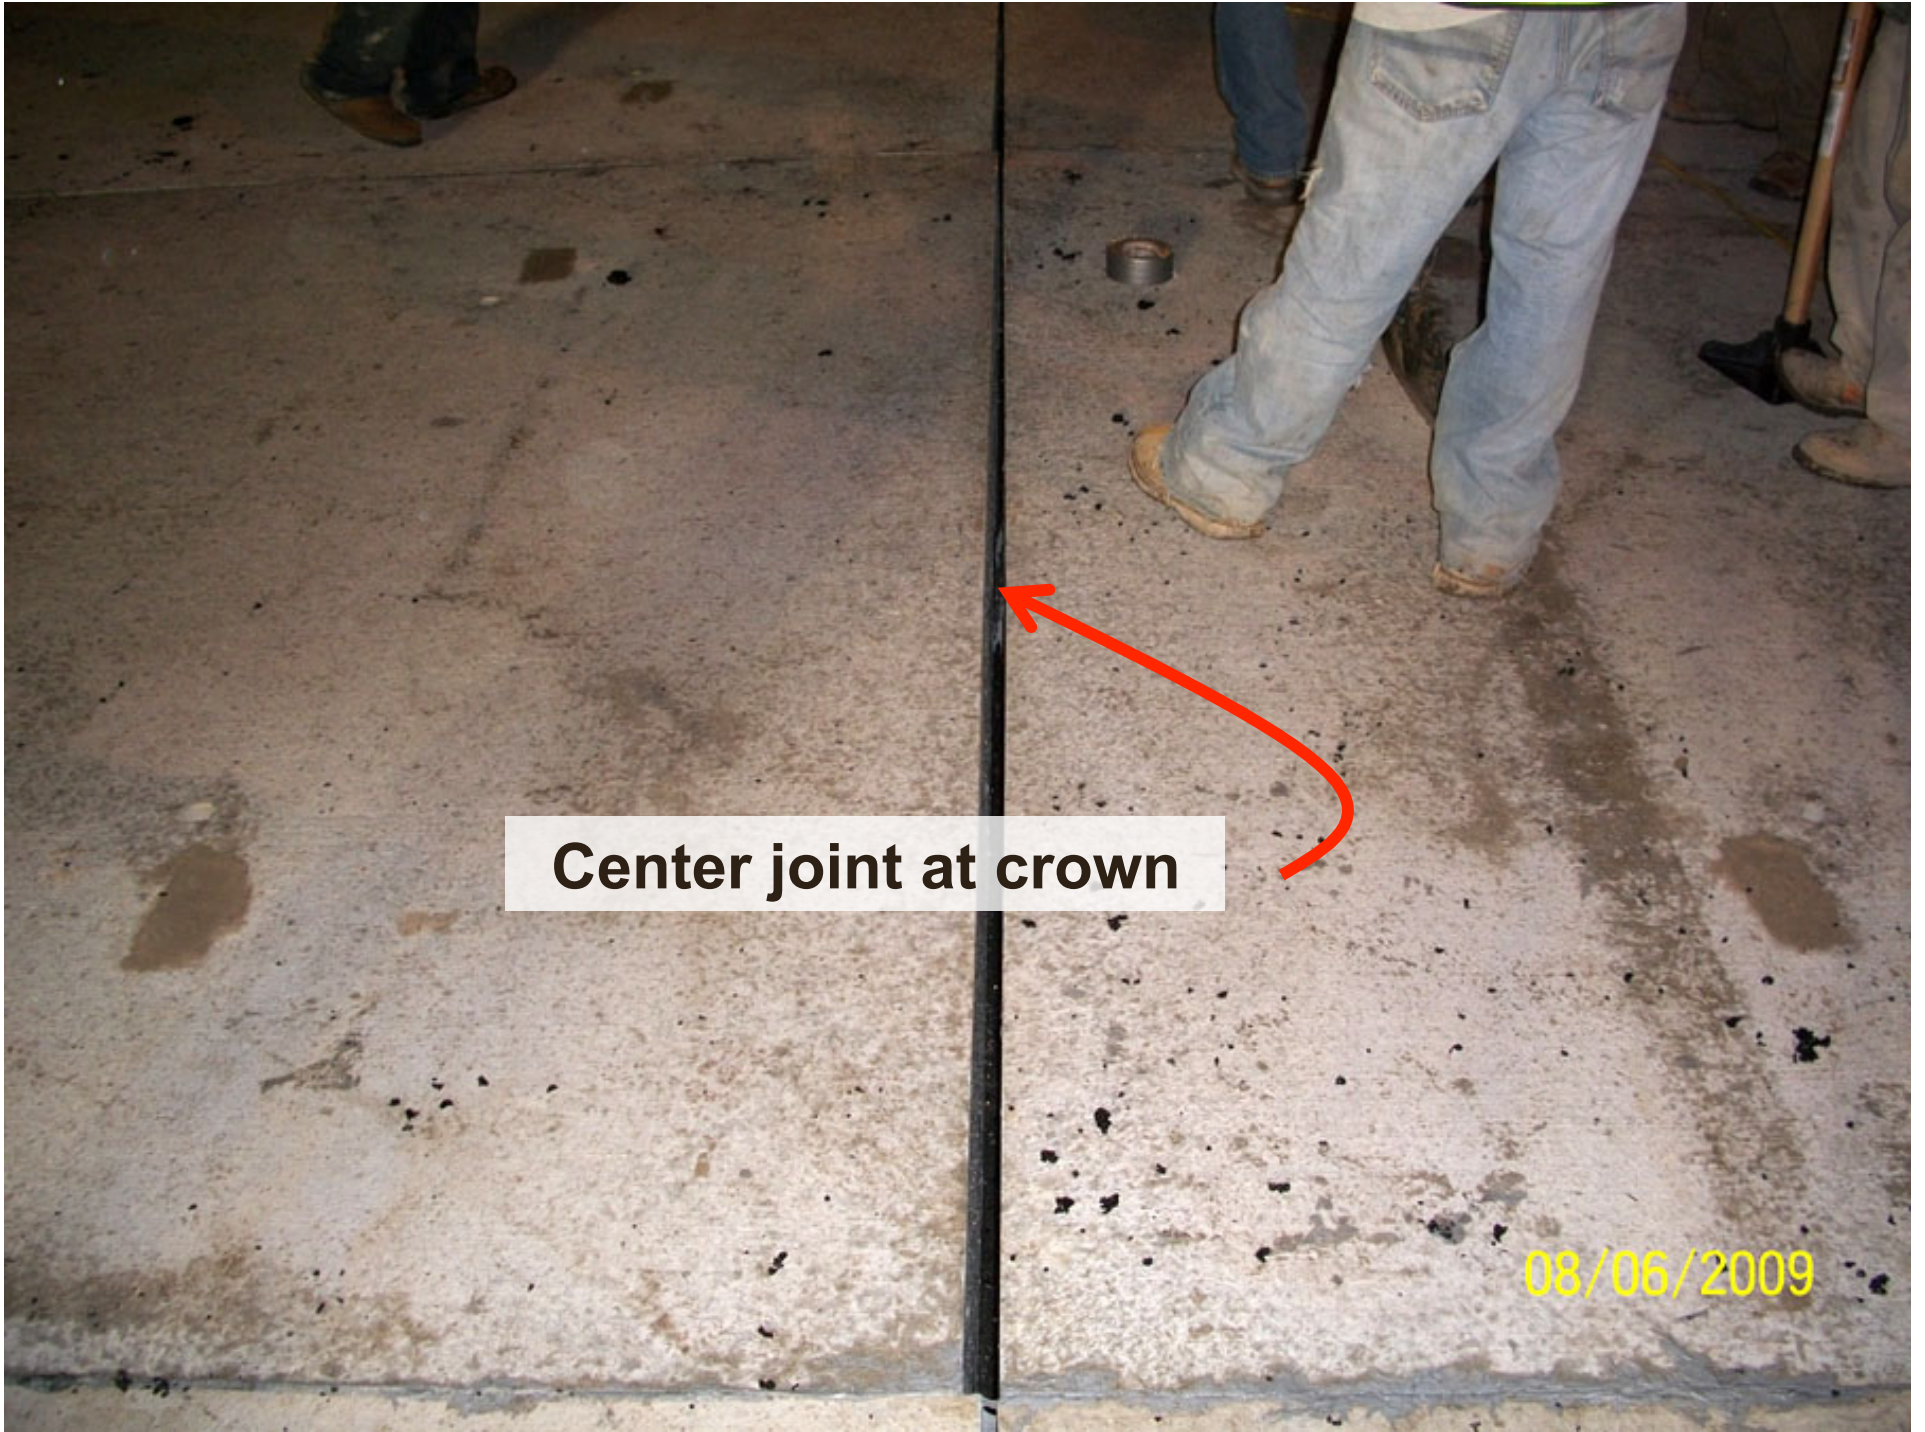
Center joint at crown

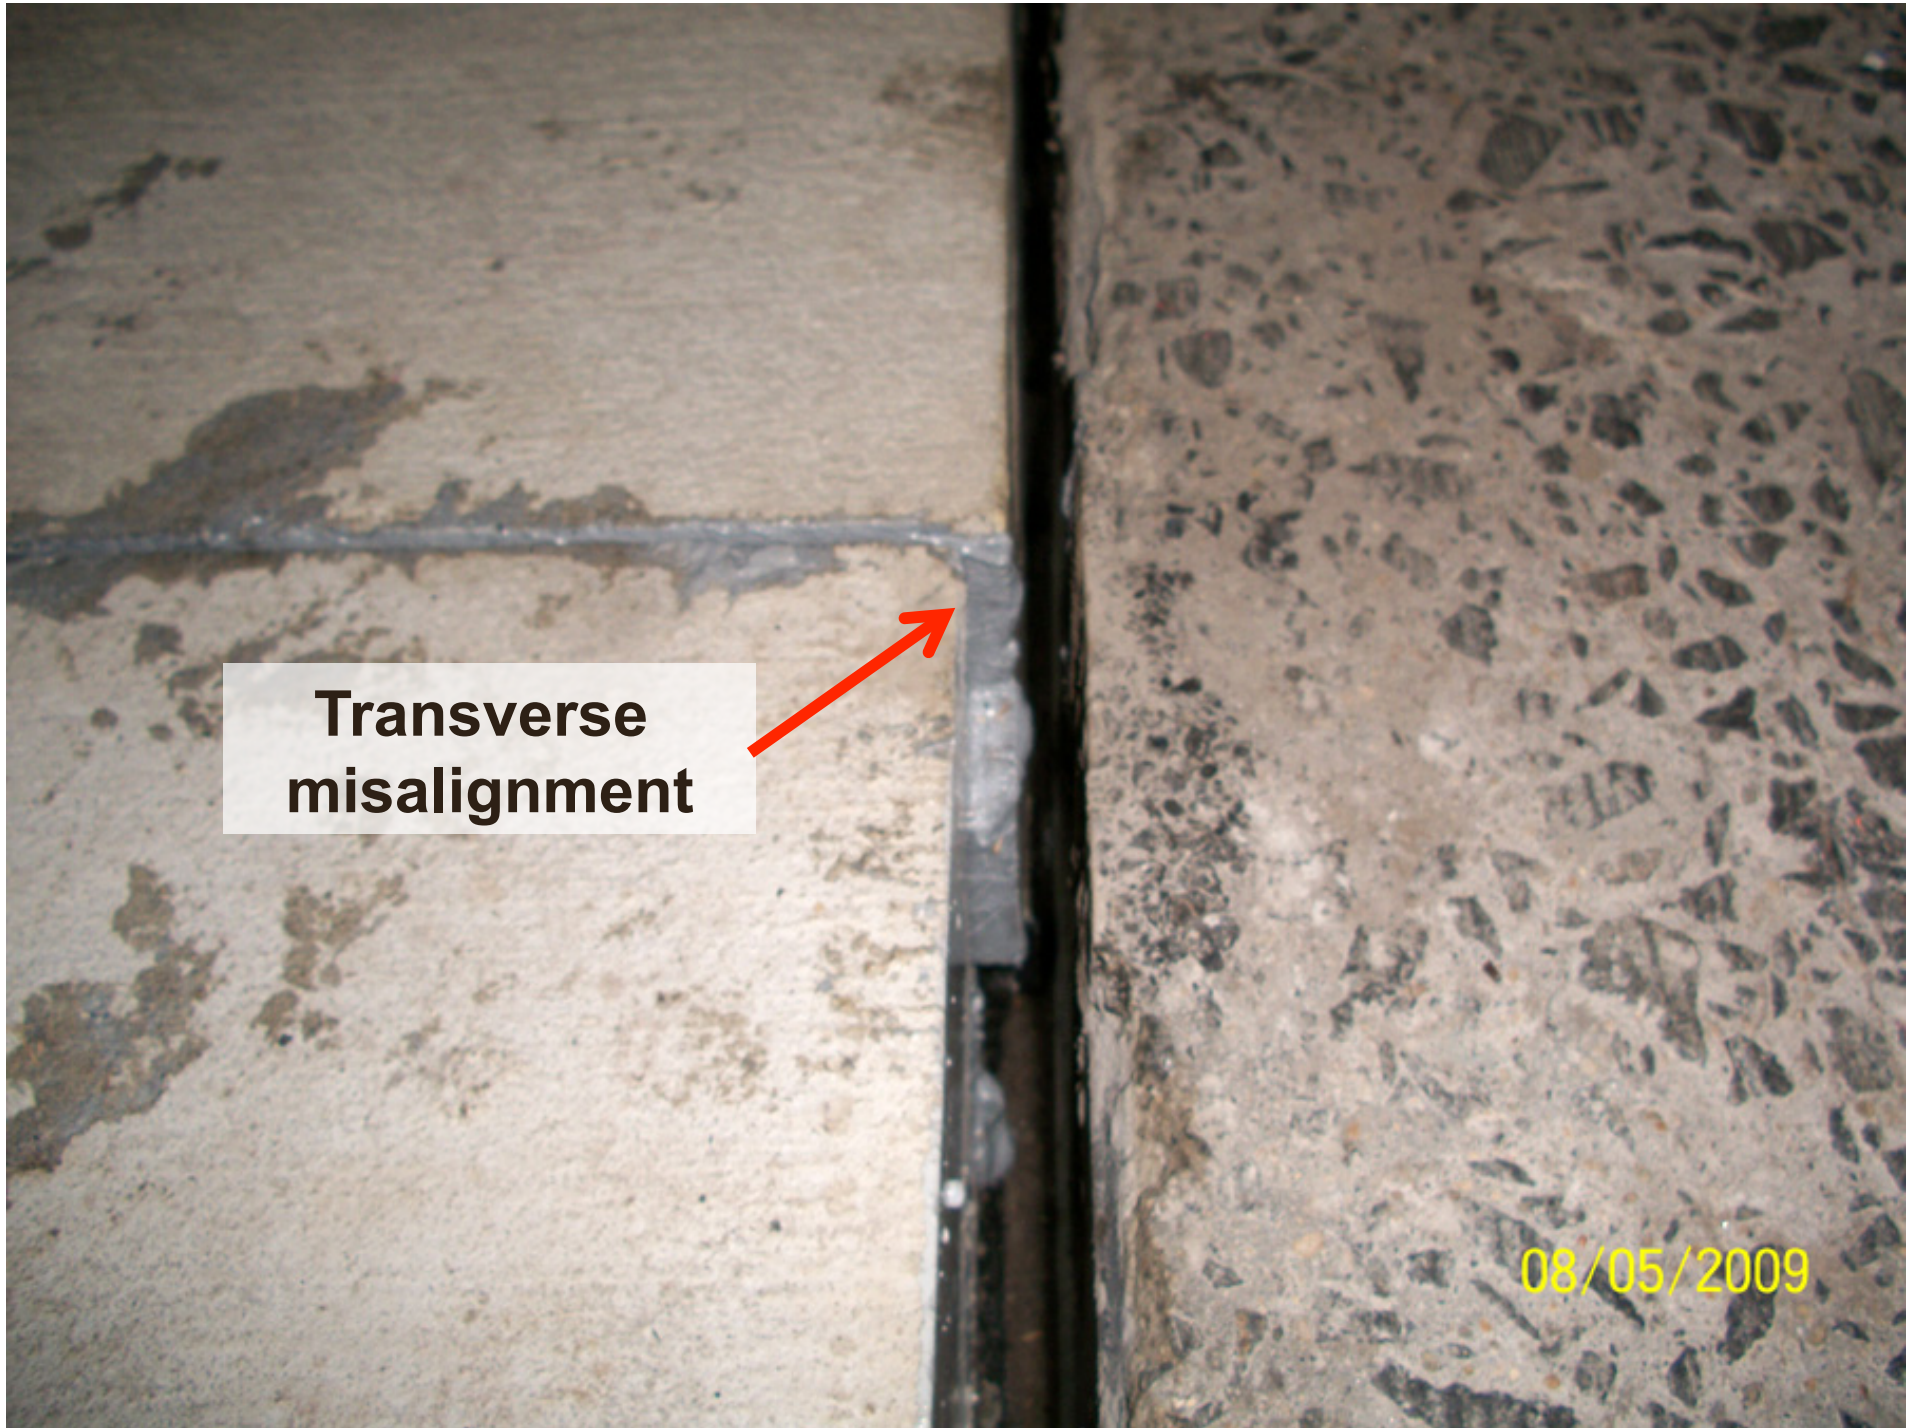
**Transverse
misalignment**

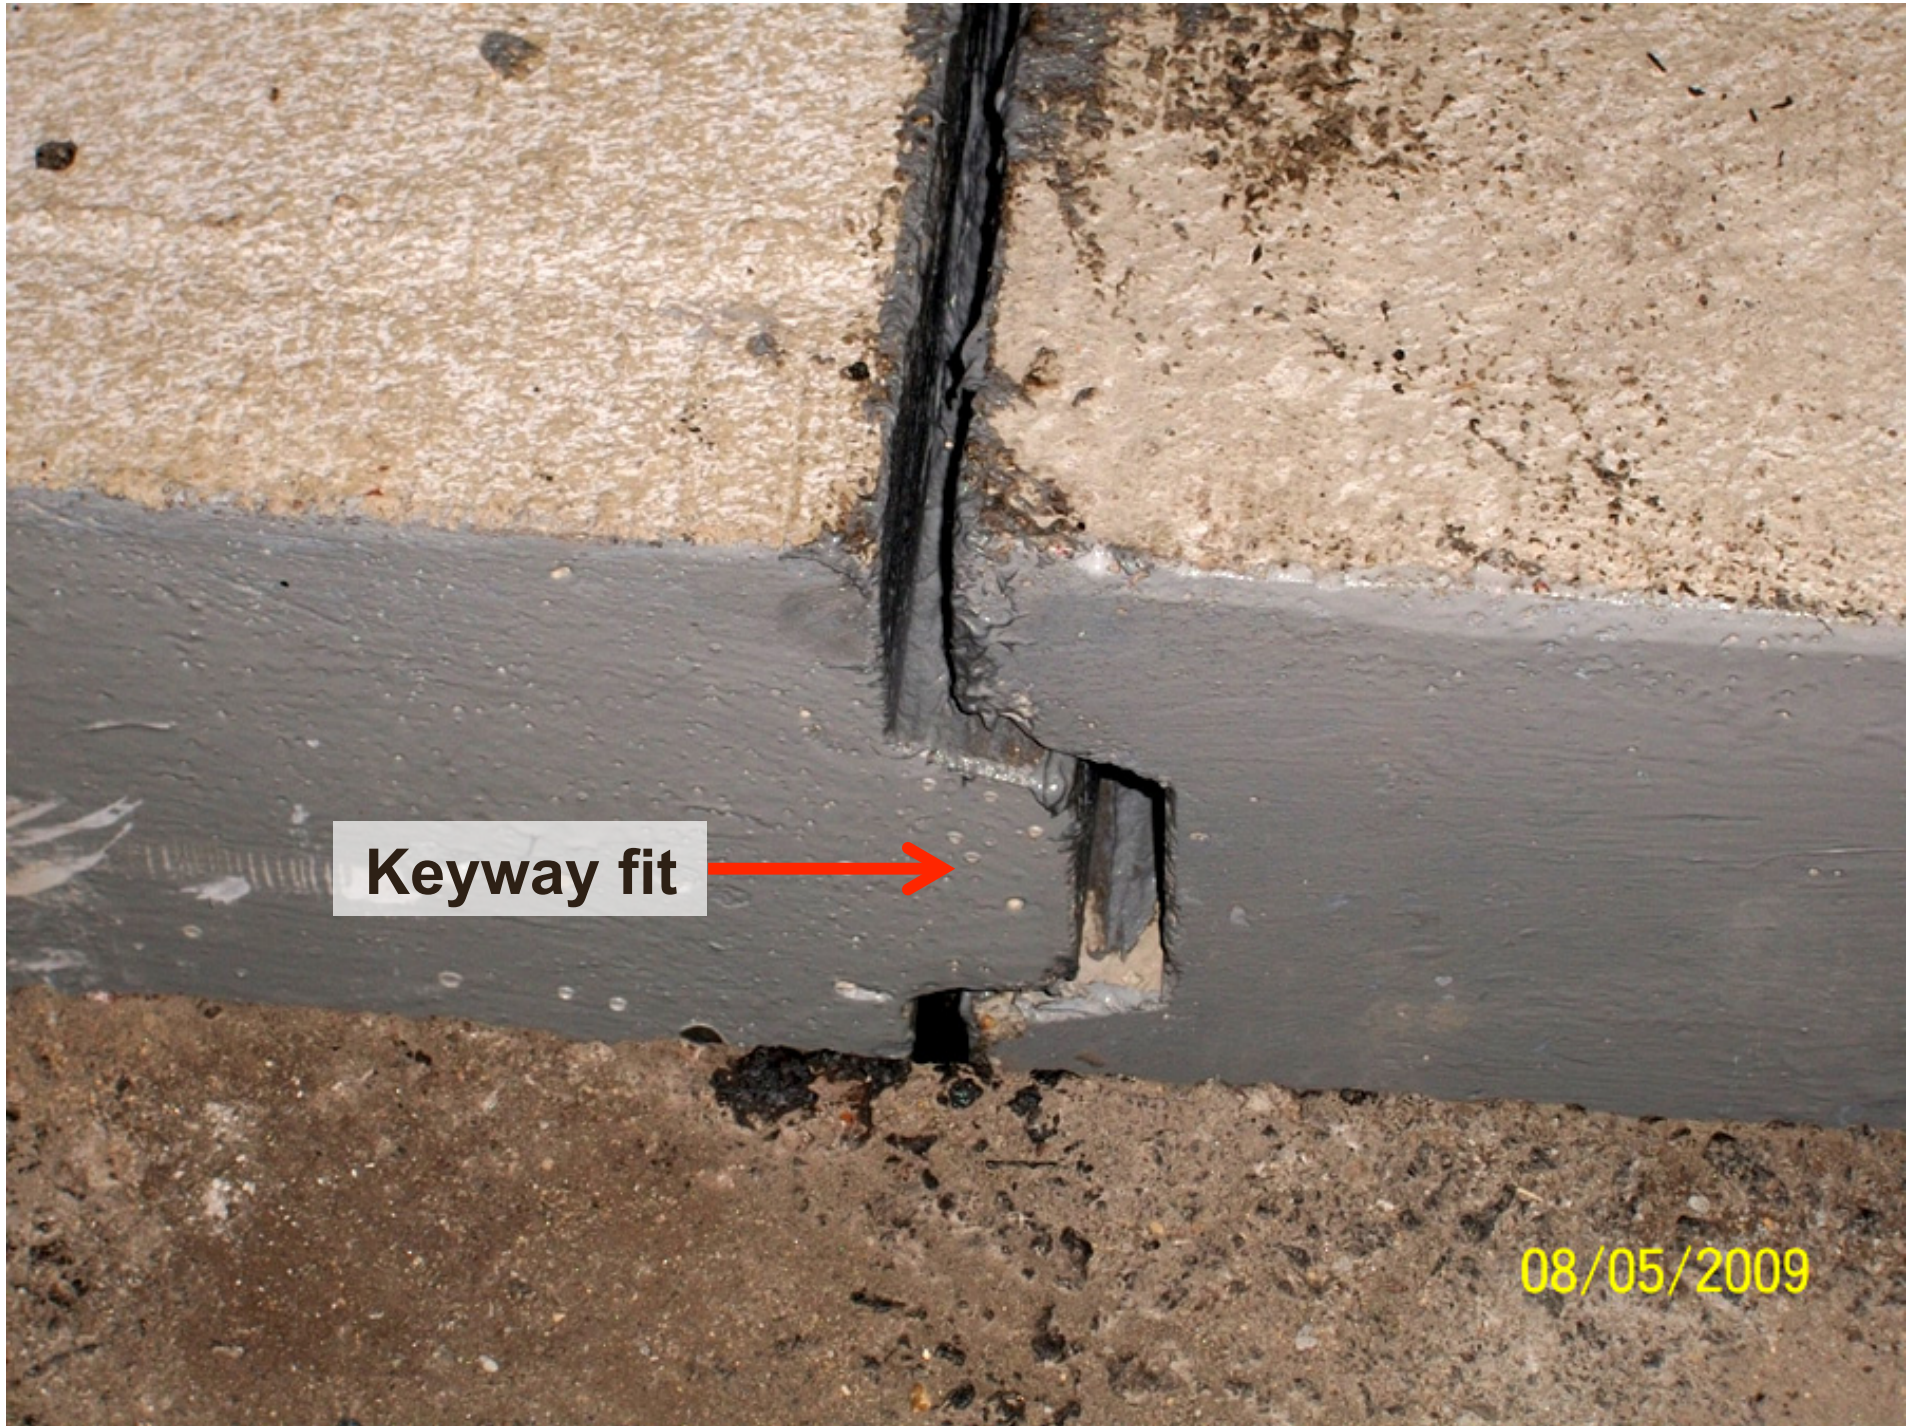
Keyway fit

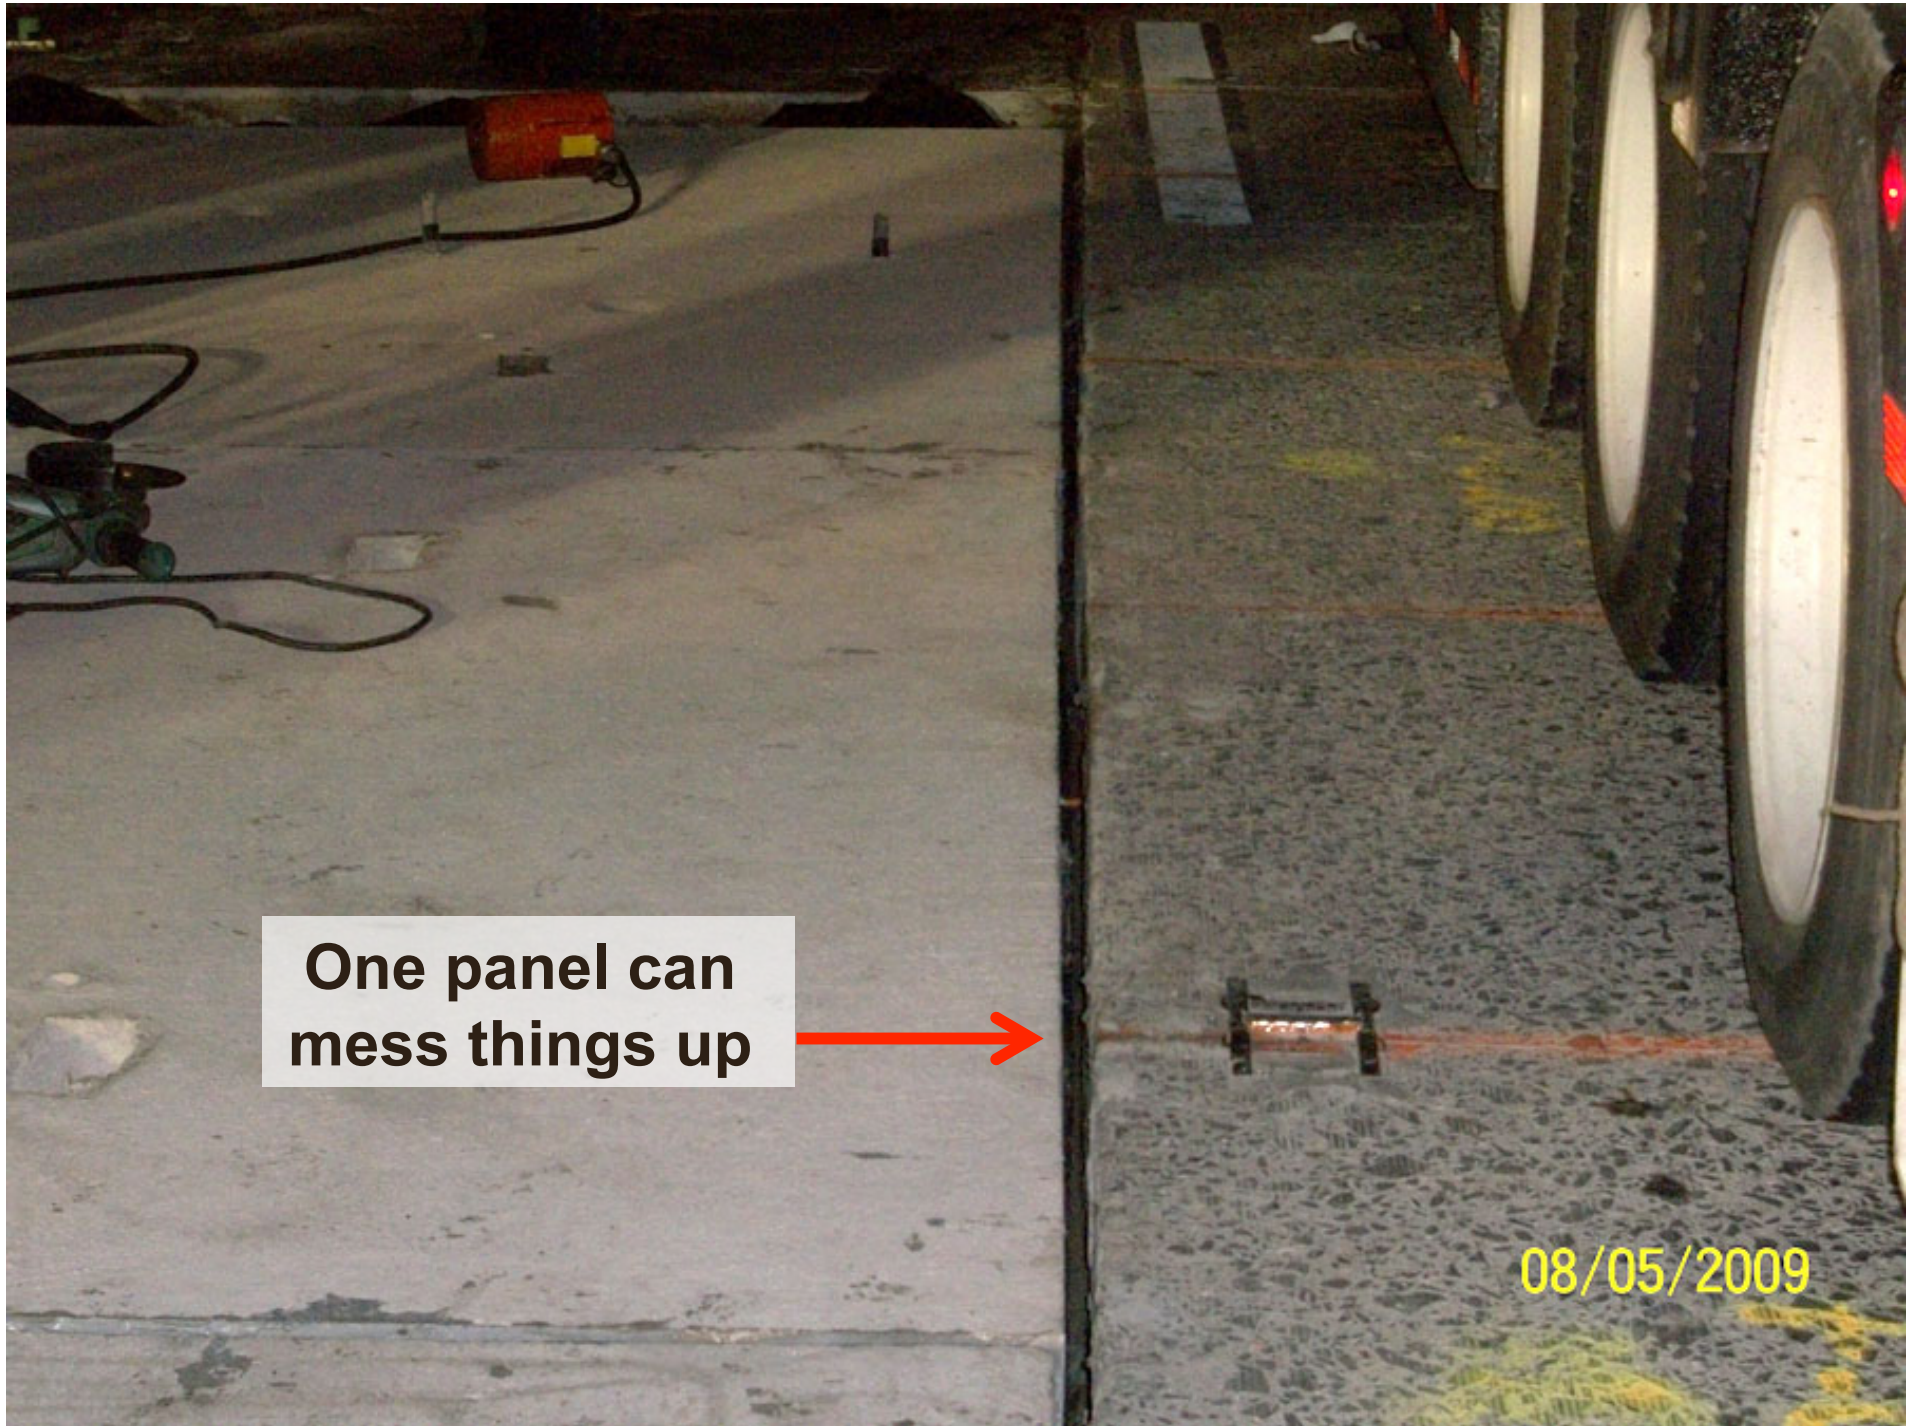
**One panel can
mess things up**

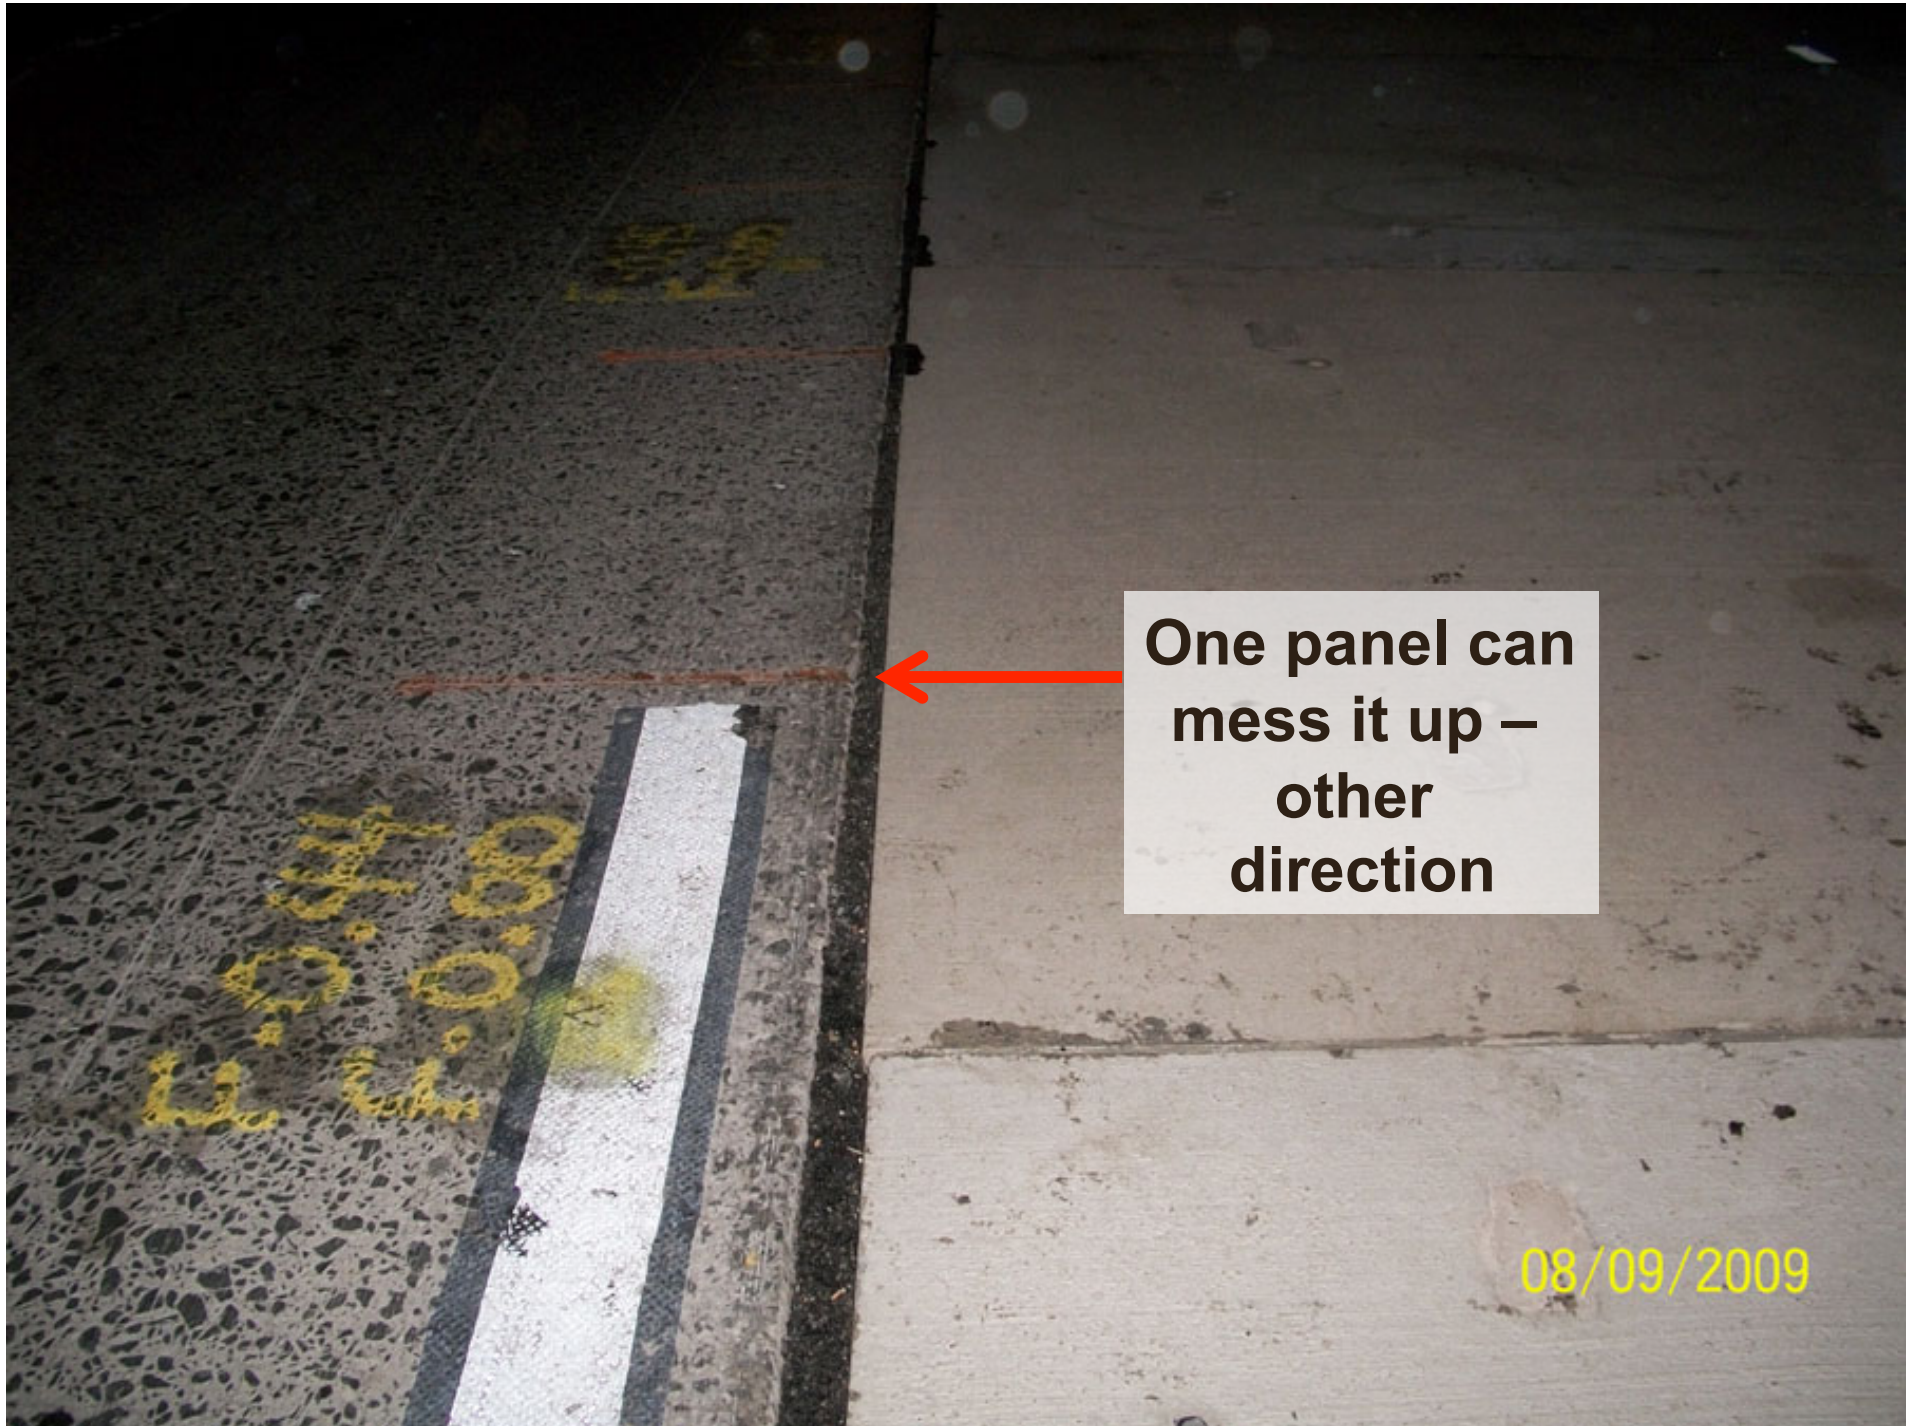
**One panel can
mess it up –
other
direction**

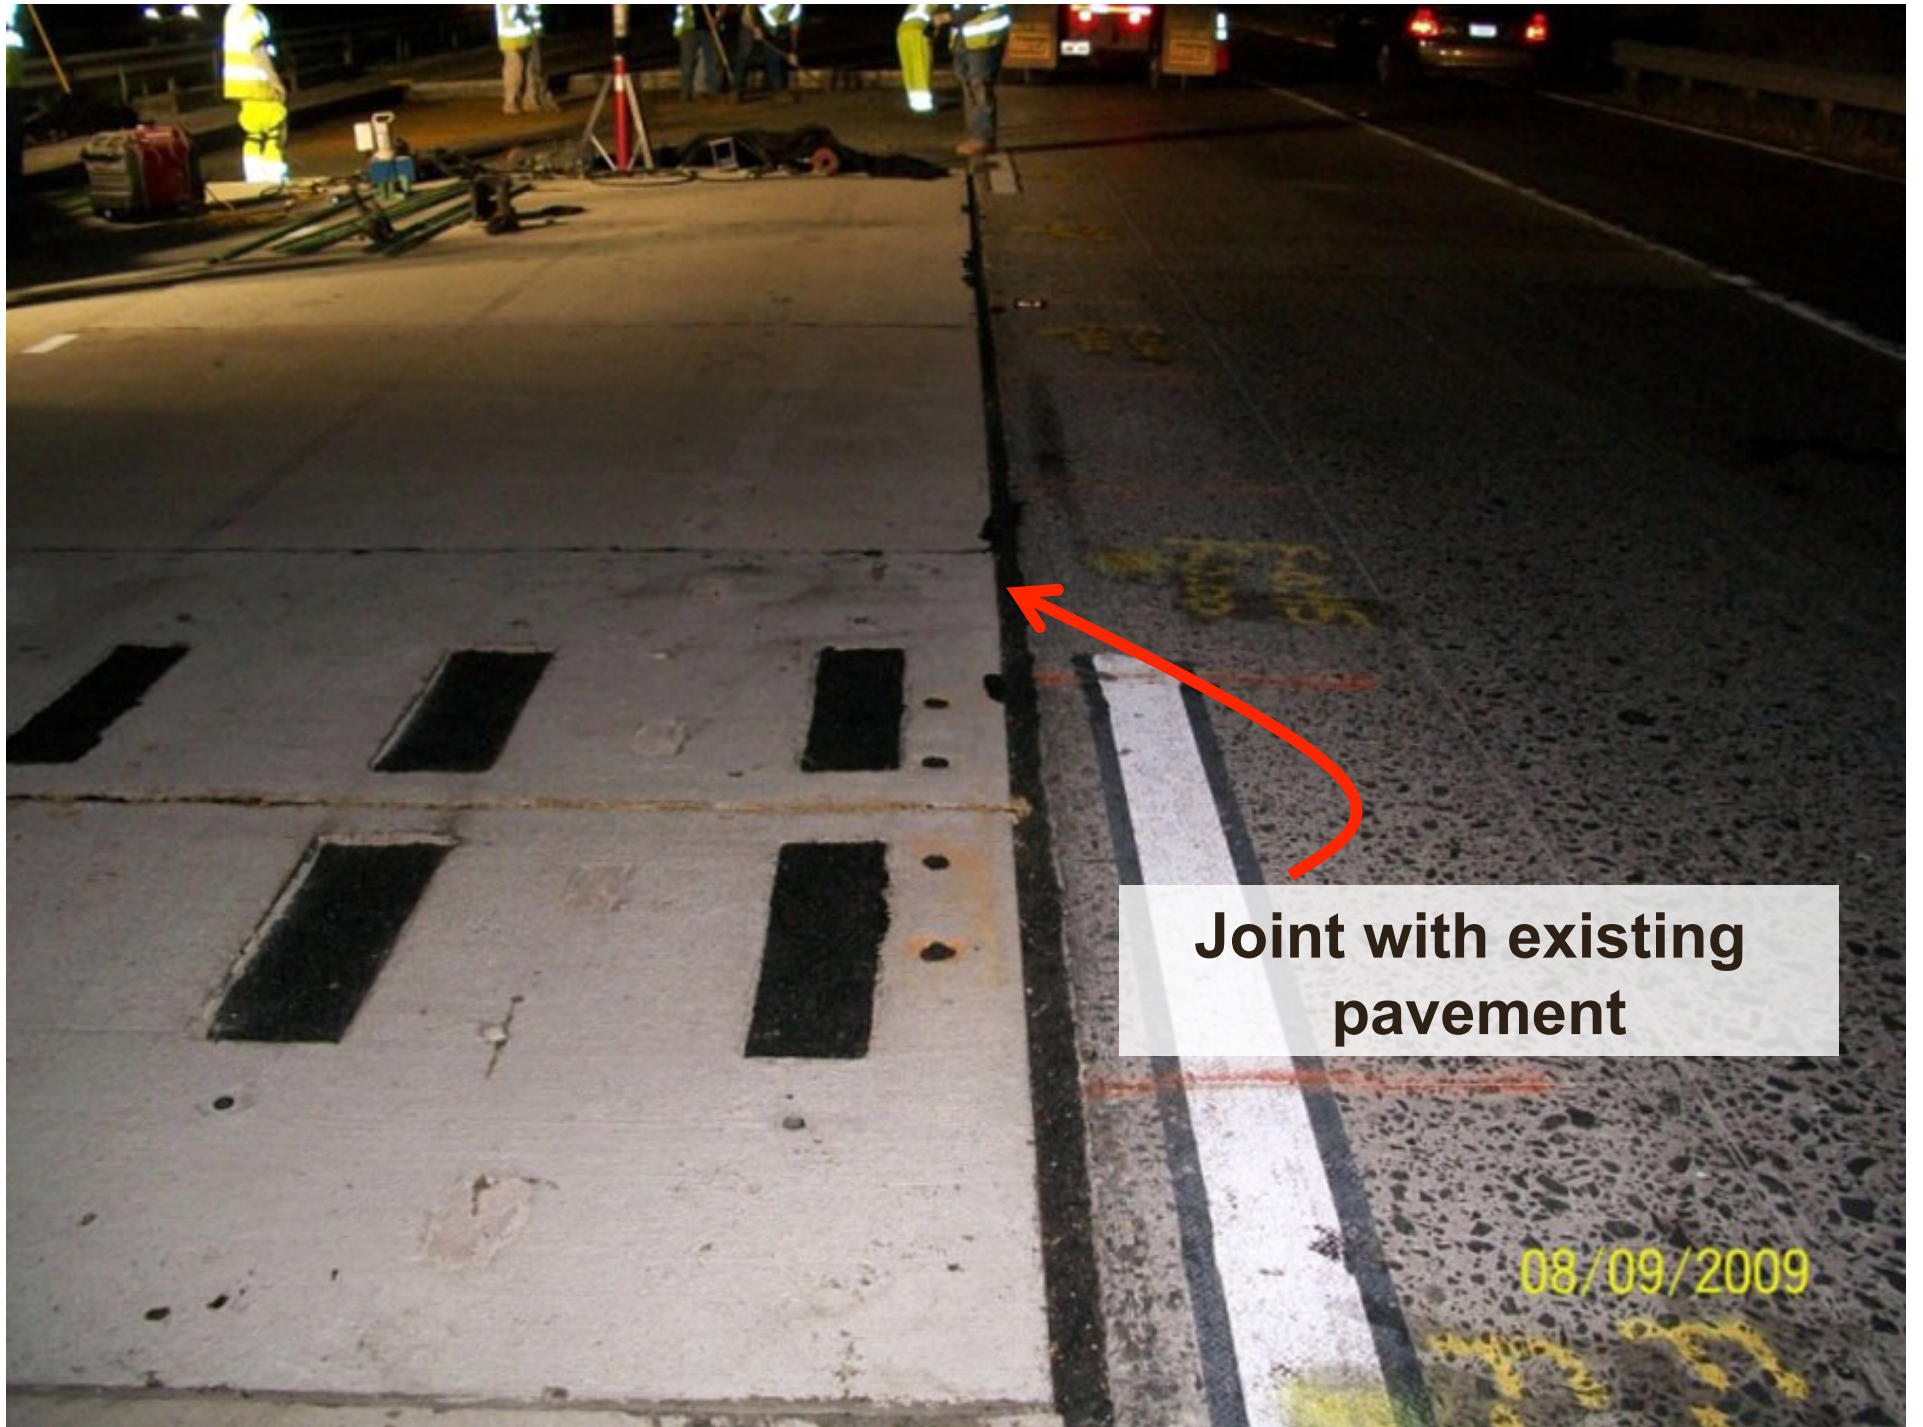
Joint with existing pavement

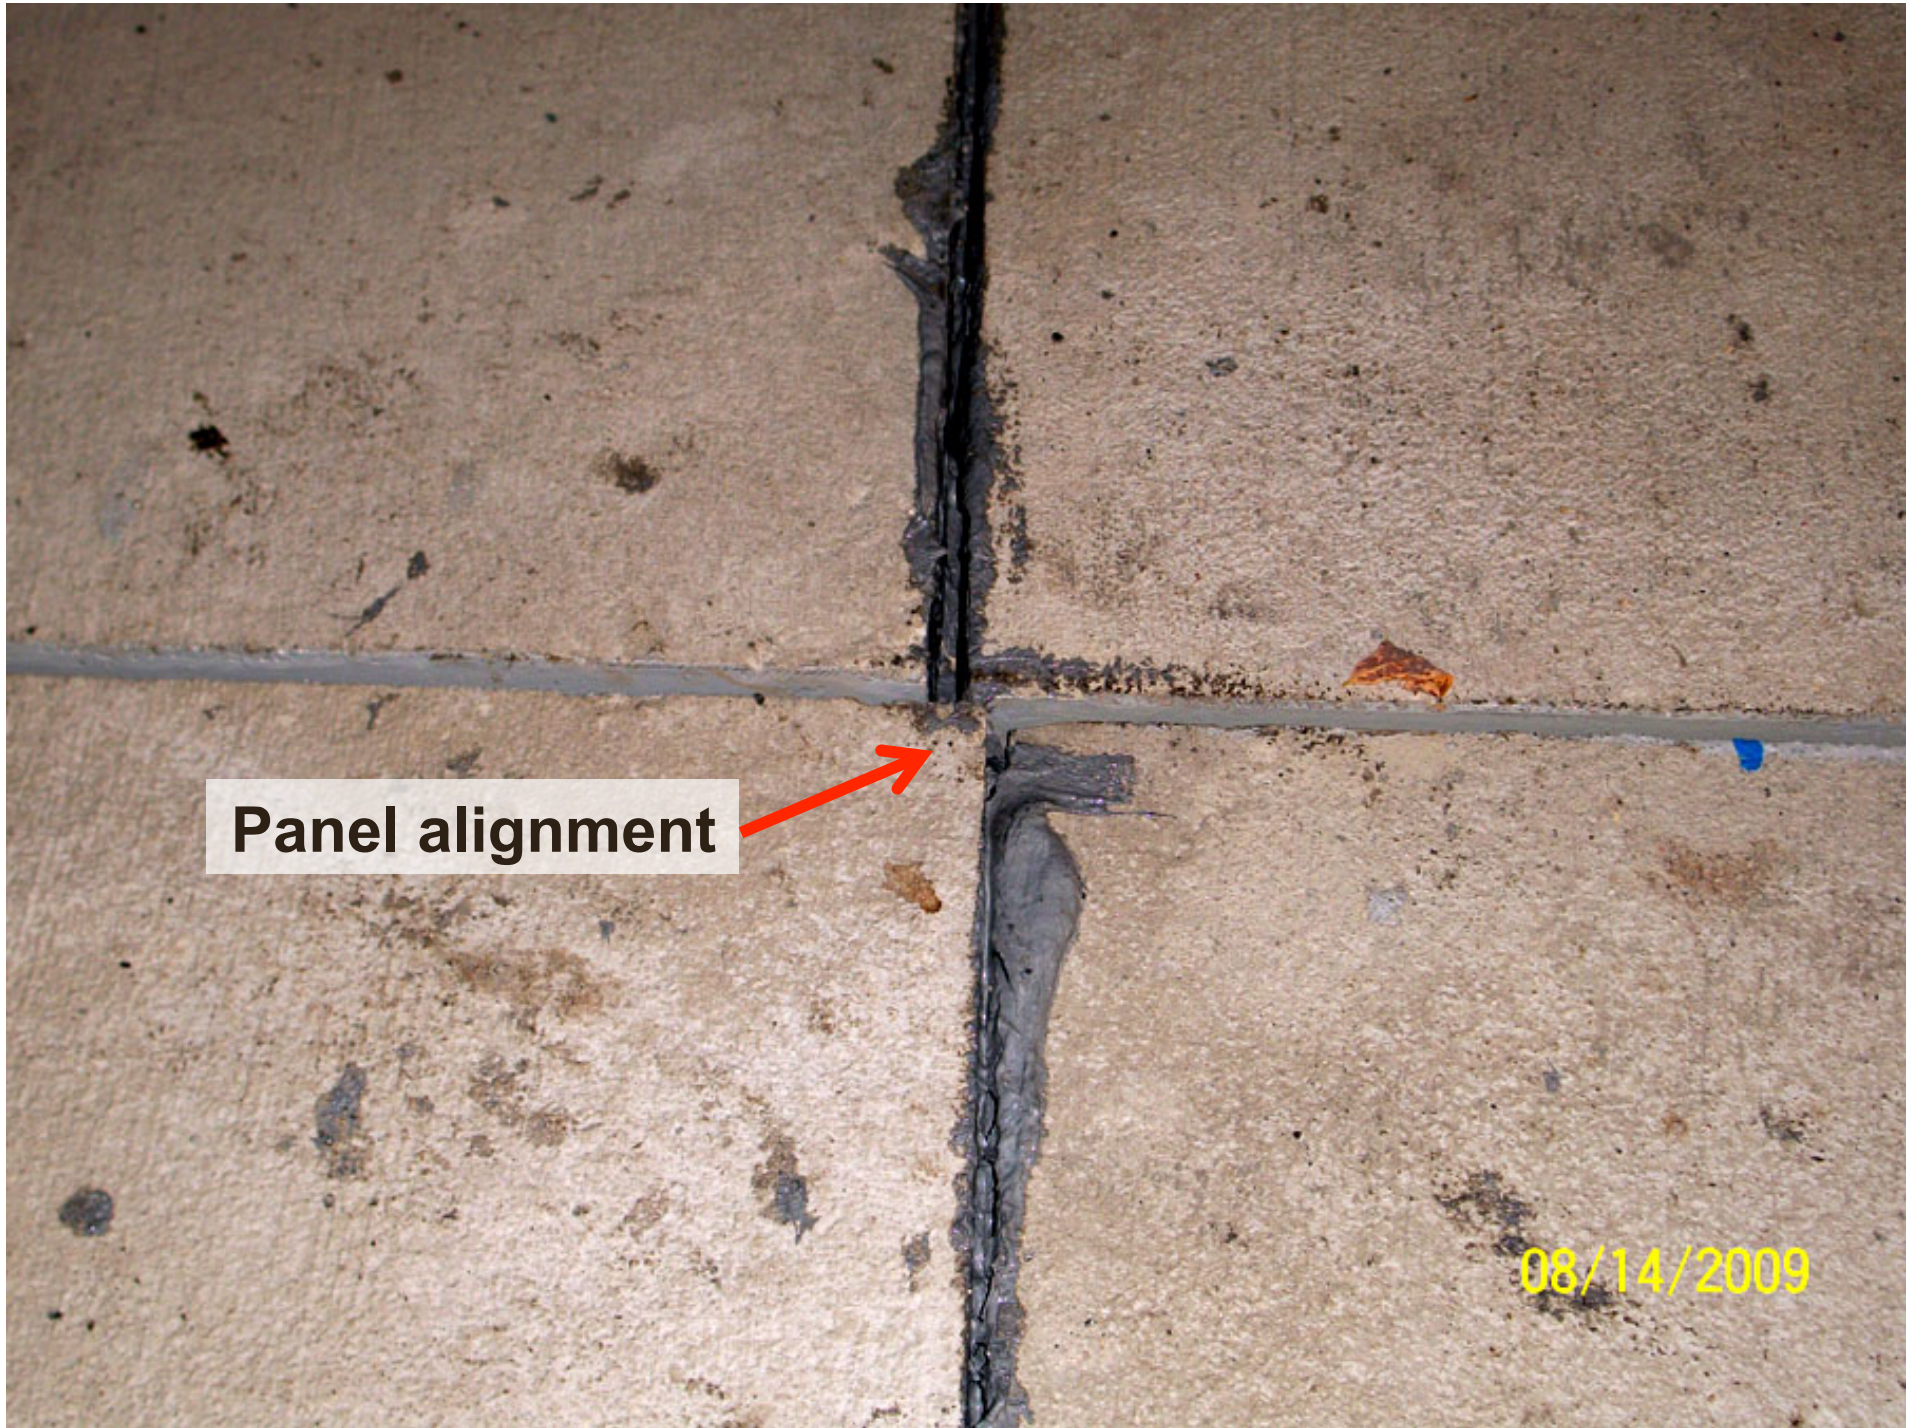
Panel alignment
