I-66 Highways for LIFE

PCI PAVEMENT COMMITTEE

Karen L. Consiglio, P.E.

September 10, 2009

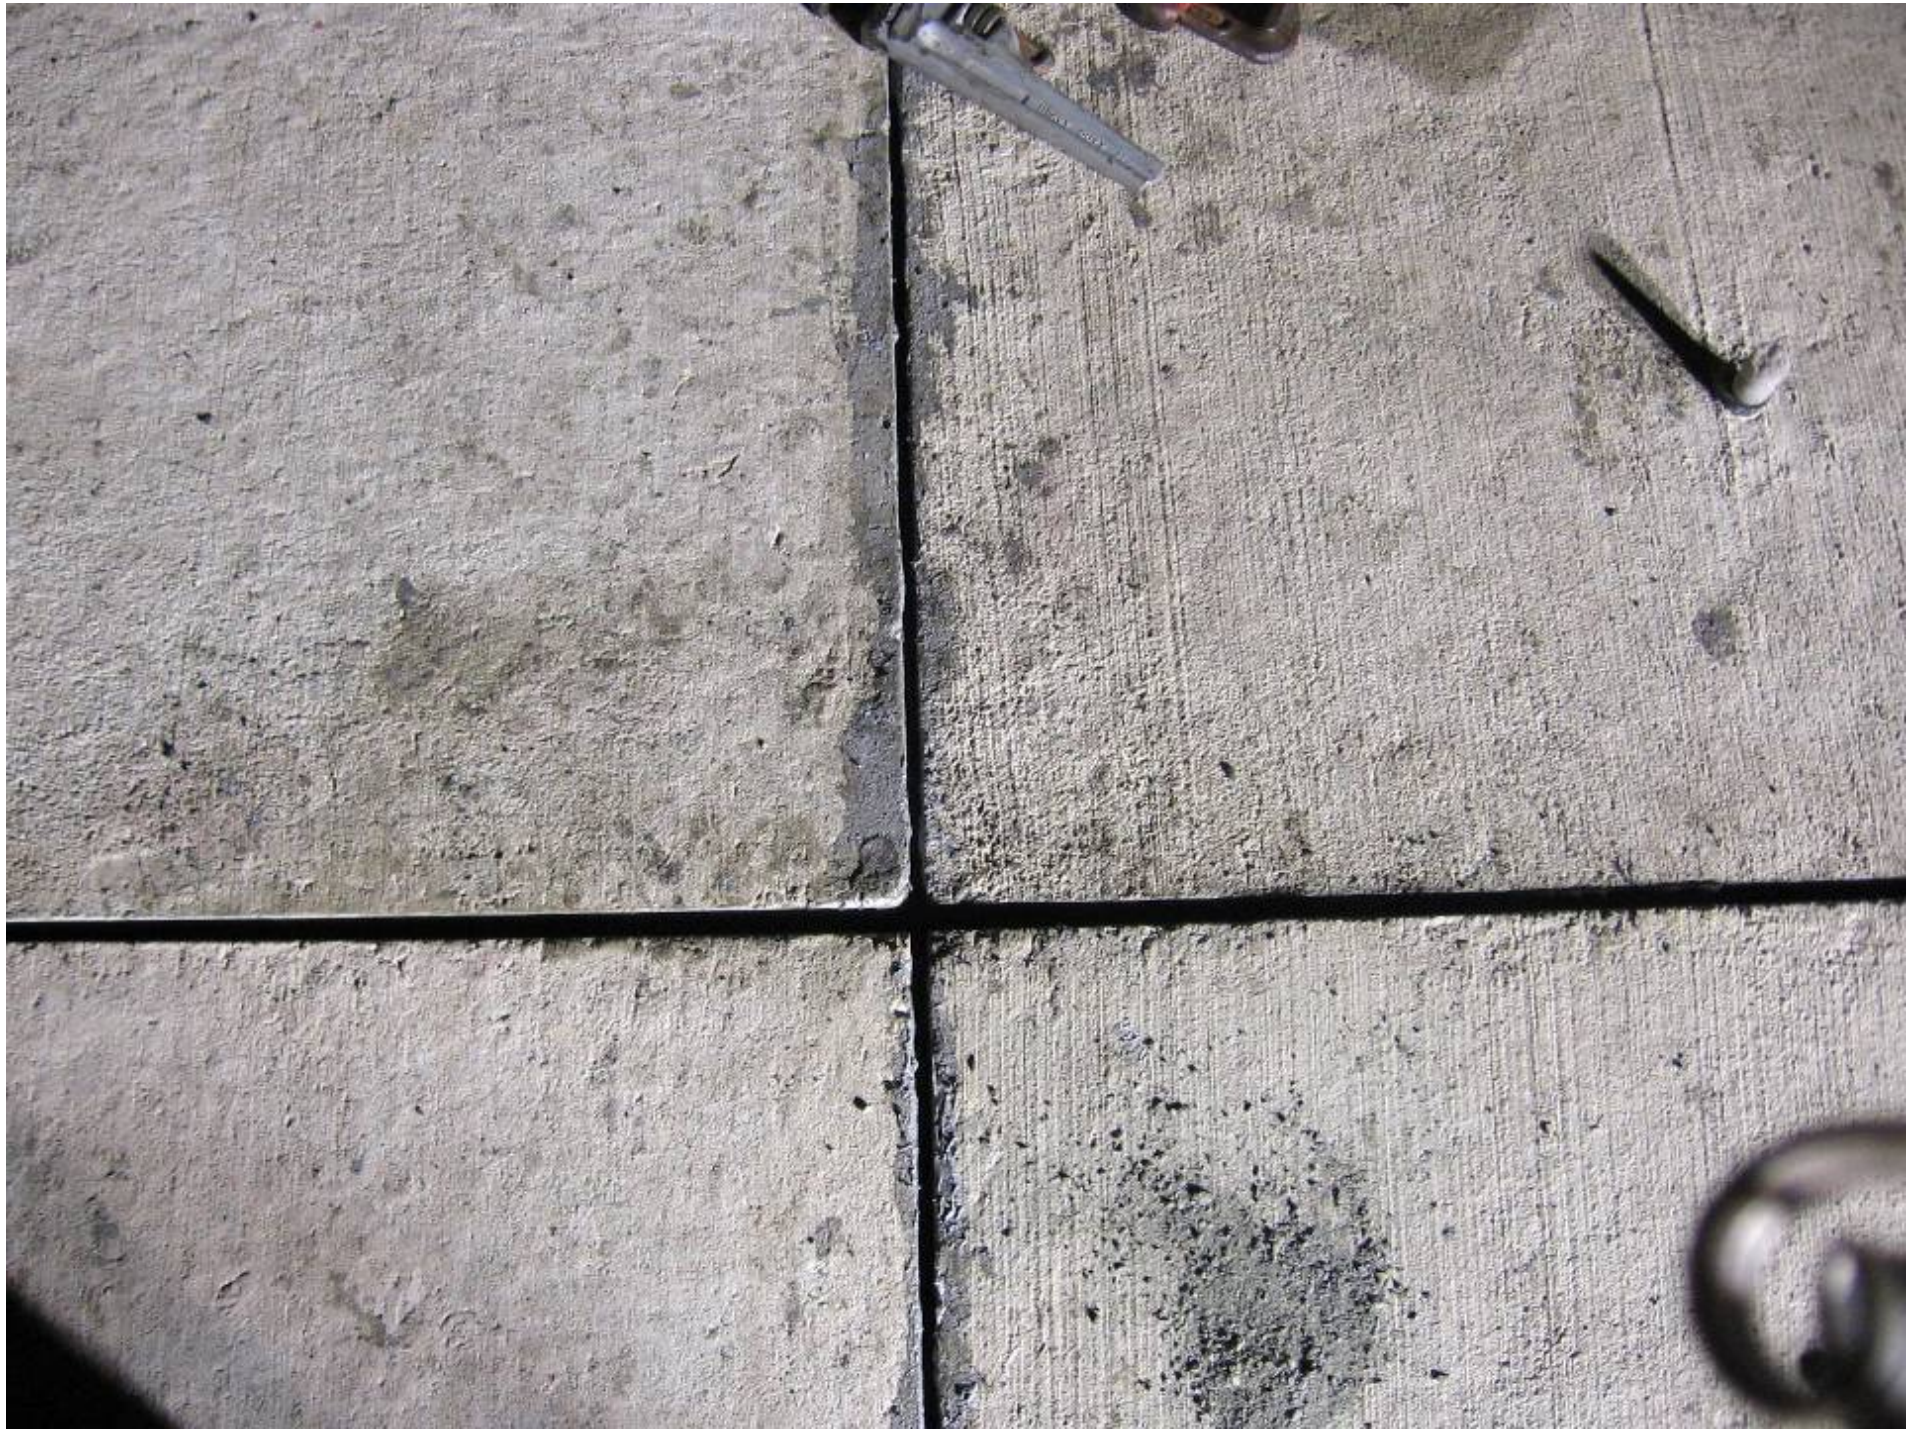
Keyway crack

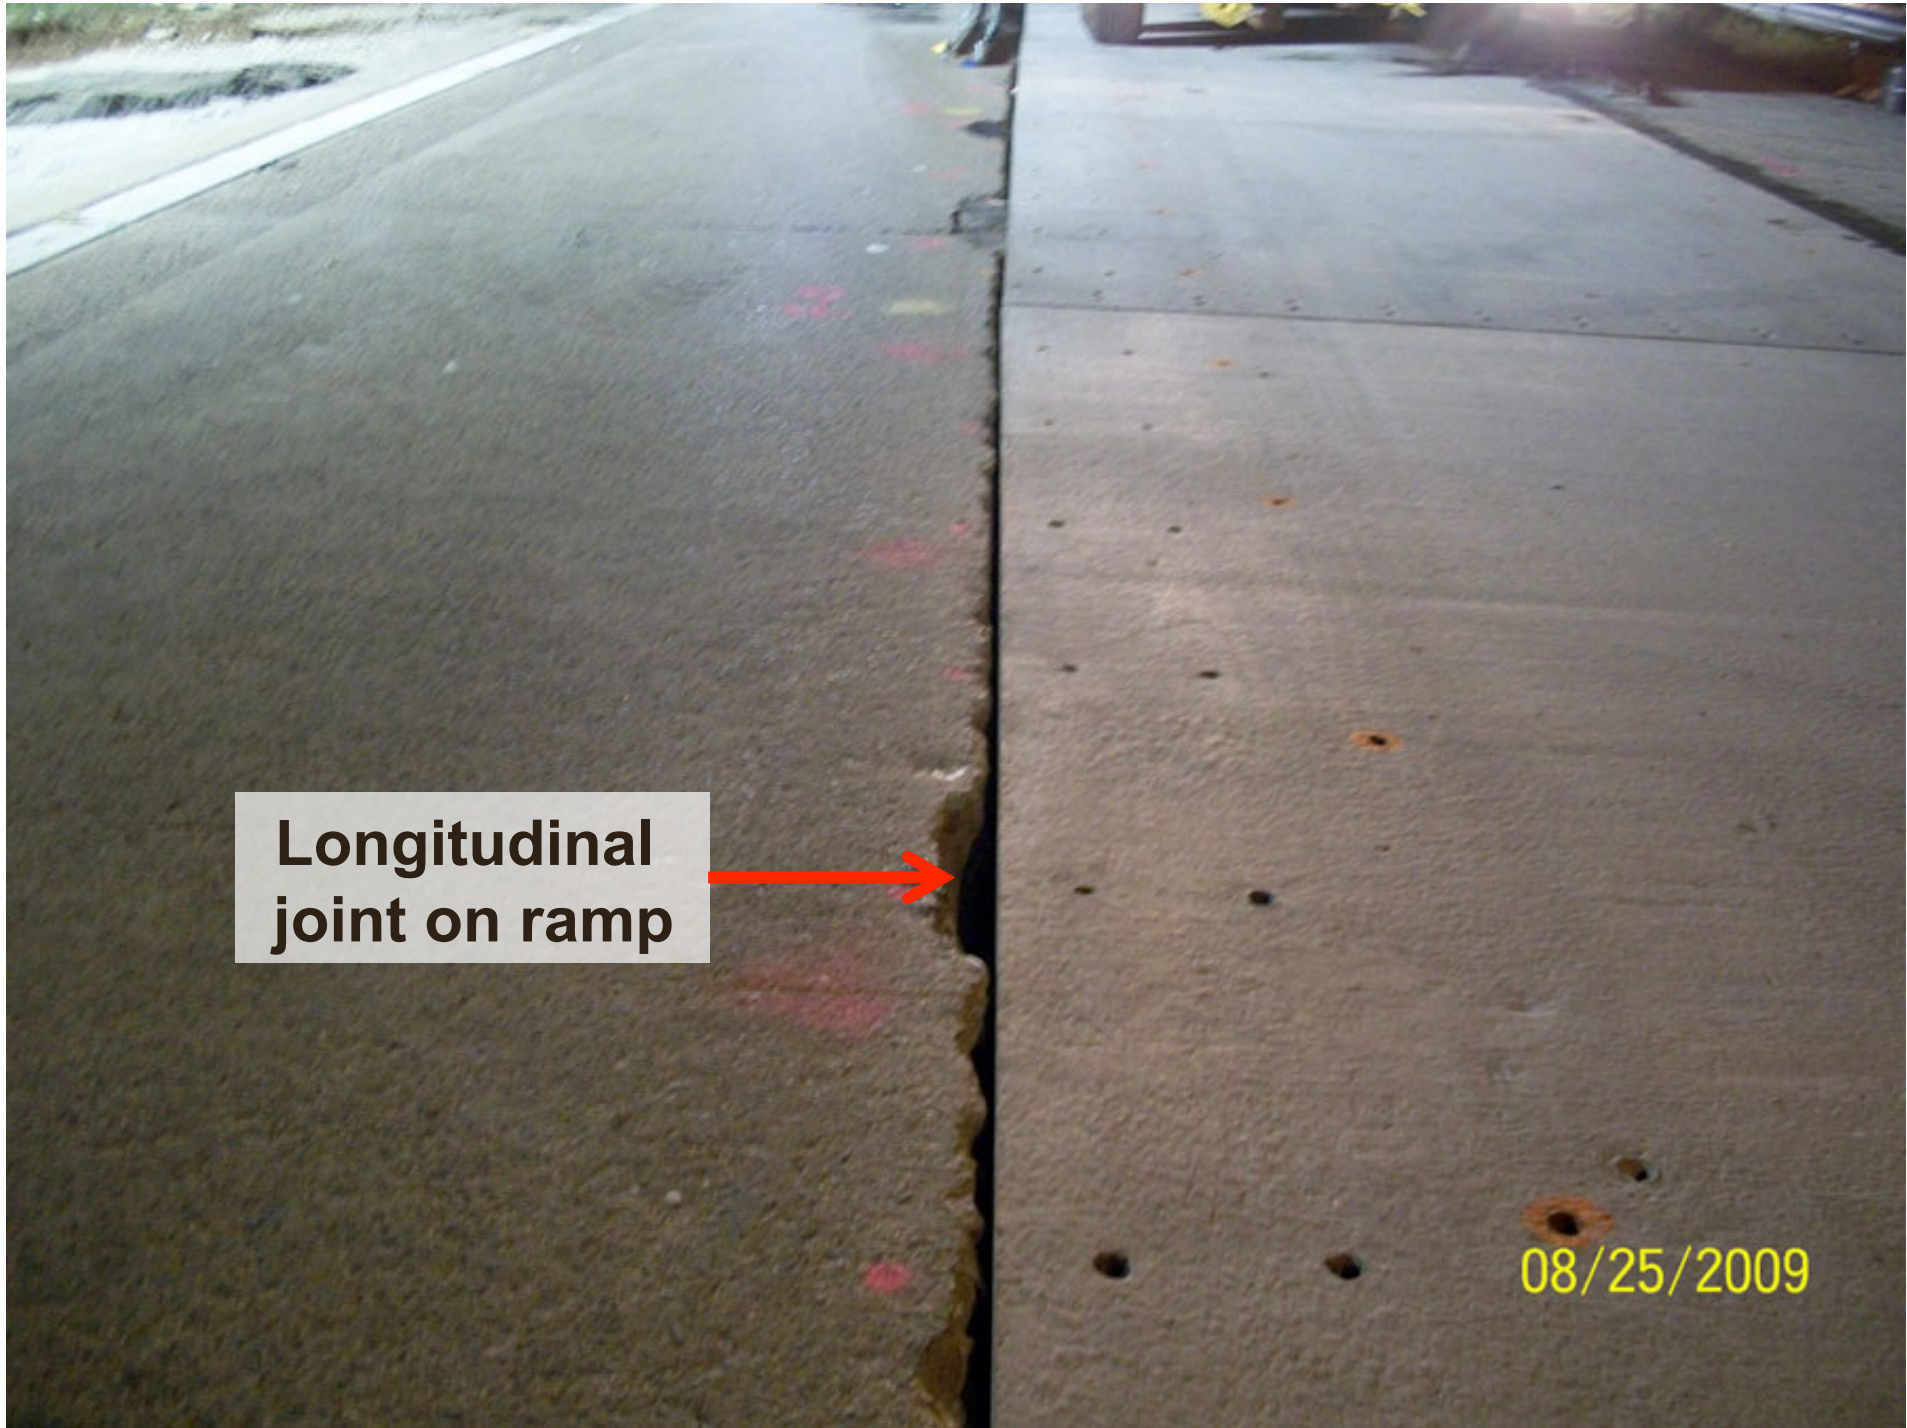
**Longitudinal
joint on ramp**

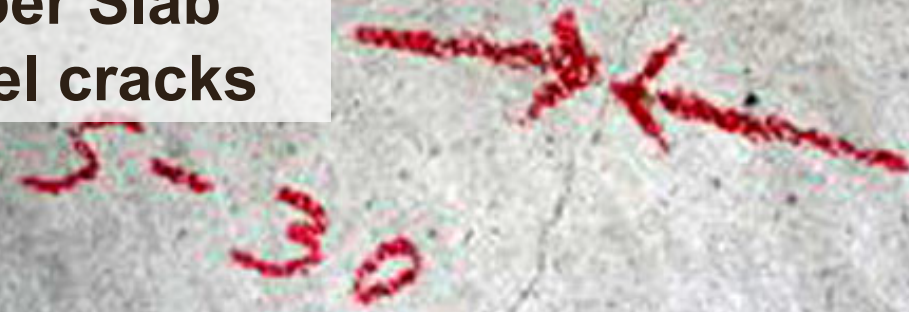
**Super Slab
Panel cracks**

**Super Slab
Panel crack
down side of
panel**
