FULL-DEPTH REPAIR OF JOINTED PCC PAVEMENTS  
CAST-IN-PLACE AND PRECAST PROCEDURES

Samuel S. Tyson  
Research Engineer

Virginia Highway & Transportation Research Council  
(A Cooperative Organization Sponsored Jointly by the Virginia  
Department of Highways & Transportation and  
the University of Virginia)

March 1976  
VHTRC 76-R44

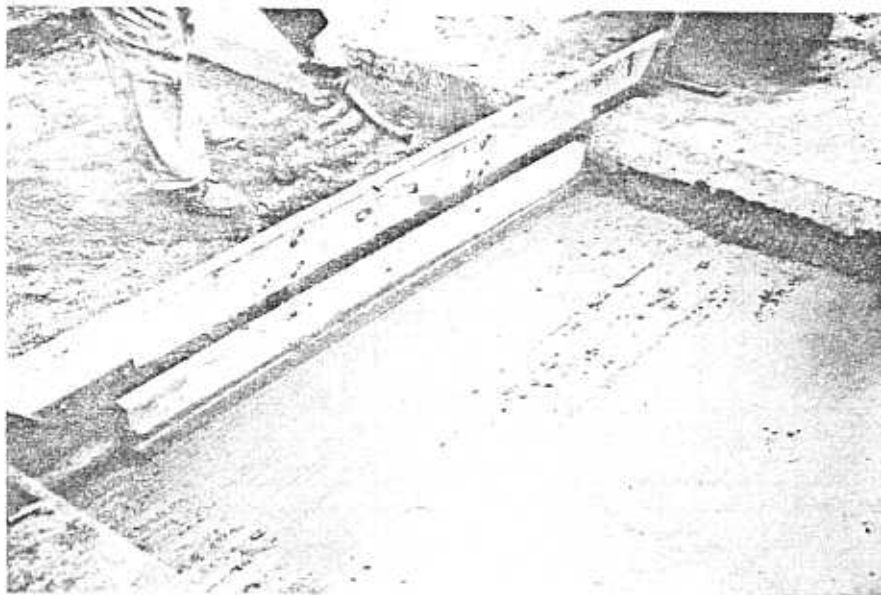
Figure 21. Stress relief at one end of repair area requiring third transverse sawcut (Michigan photo).

Sawing of the repair limits was a major activity because the siliceous aggregates in this pavement were difficult to saw, both in terms of time and of wear to the saw blades. The cutting rate in this case was approximately 0.3 ft./min. (0.1 m/min.). The repair locations were sawed several days or more prior to a precast slab installation to add flexibility to the operation. These initial installations took place in cool to cold temperatures of late winter and early spring. In warmer weather, and with delays of more than one week between sawing and removal, some difficulty was experienced in removing the concrete due to increased joint stresses. Experience and judgement are needed to anticipate the occurrence of this problem at specific locations; and if stress levels will be high enough to restrict or prevent easy lifting of the damaged concrete, a third saw cut should be made initially so that stress relief may be accommodated by jackhammering an opening as in Figure 21.
